Service Bulletin

PRELIMINARY INFORMATION

Subject: Service Park Assist Message At Start Up With DTC U0159 And/Or False Alerts

Models: 2015-2016 Cadillac Escalade Models
2014 Chevrolet Silverado 1500
2015-2016 Chevrolet Silverado, Suburban, Tahoe
2014 GMC Sierra 1500
2015-2016 GMC Sierra and Yukon Models
With Ultrasonic Park Assist System (RPO UD5 or UD7)

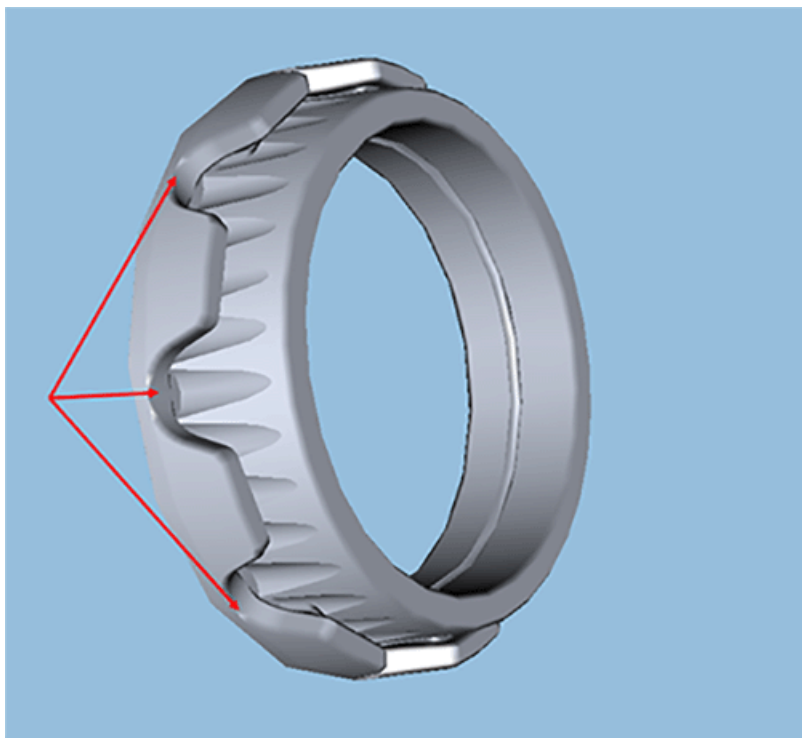
If the front park assist sensor(s) have been replaced previously for any reason, some replacement park assist sensors were coming with the incorrect sensor ring.

The incorrect sensor rings did not have the scallops/reliefs molded into the ring, as shown below.

If the sensor and ring are not properly installed and there is binding/misalignment/etc. of the sensor/ring, it will continue to cause unwanted/false alerts.

Remove the front park assist sensor(s) and inspect the sensor rings for scallops/reliefs molded into the ring.

If there are no scallops/reliefs molded into the ring, the wrong sensor ring(s) are installed. Replace the sensor ring(s) with GM part number 84075328, shown below.

It is imperative when installing the sensor rings to pay close attention that the sensor and ring are properly installed.
