Service Bulletin

Subject: Delayed Engagement After Sitting With Engine Off - Clutch Slow to Fill

Delayed Harsh Engagement - Clutch Slow to Fill

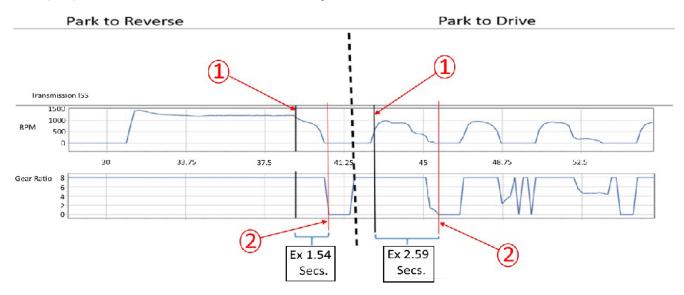
Delayed Engagement Park to Reverse or Drive is present if the time difference between Gear Selected (Pt. 1) and Transmission Input Shaft Speed reaching 0 RPMs (Pt. 2) exceeds 3 seconds. Foot is HELD on Brake during maneuver.

The slide bar on the bottom left of GDS2 Screen can be used to aid in discerning time (Pt. 2 – Pt. 1) = Delayed Engagement Time.
