Service Bulletin

Subject: Front or Rear Side Door Glass/Window Loose, Will Not Move Up or Down

Brand:	Model:	Model Year:		VIN:		Engine:	Transmission:
		from	to	from	to		
Chevrolet	Cruze	2010	2015			All	All
Chevrolet	Cruze (VIN P)	2016	2016

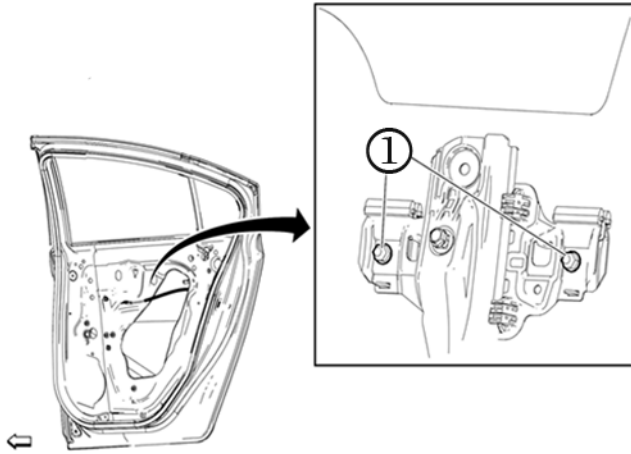
Note: The procedure and graphics below are showing a front side door. If working on a rear door, the regulator would look like the one shown in the graphic above, but the service procedure would be similar.
