# Service Bulletin

**Subject:** Sharp Edge on Underside of Trunk Shelf

Brand:	Model:	Model Year:		VIN:		Engine:	Transmission:
		from	to	from	to		
Buick	LaCrosse	2015	2016			All	All

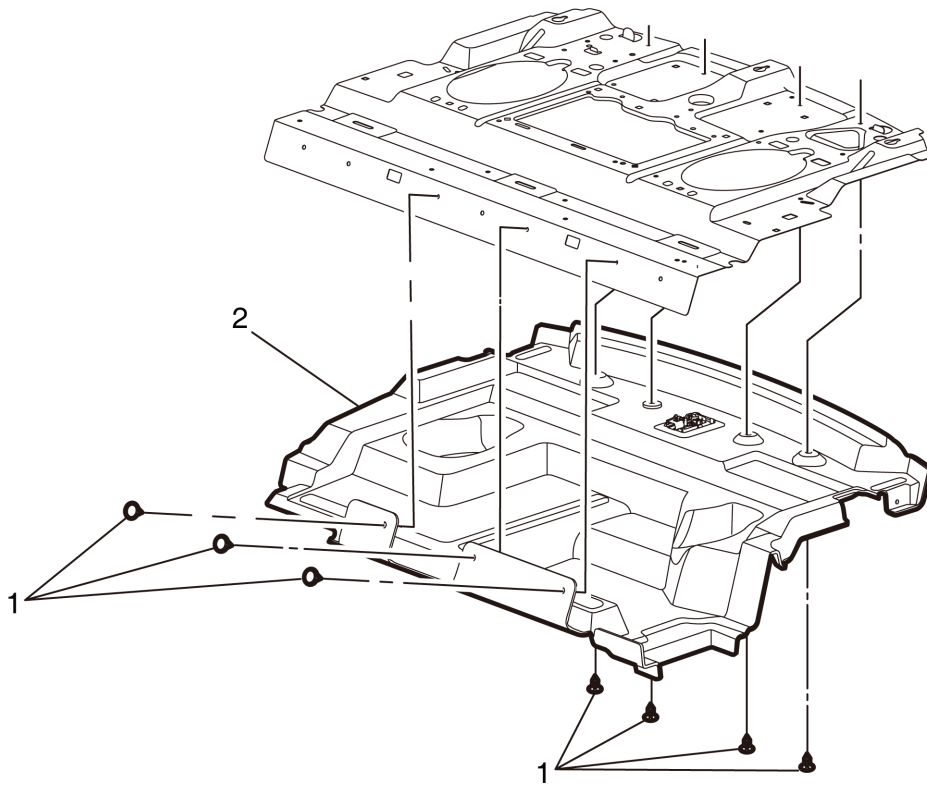
<b>Condition</b>	Some customers may comment on a sharp edge on the underside of the trunk shelf.
<b>Cause</b>	This may be caused by the underside trim piece (rear window panel stowage compartment cover) being removed from some vehicles, leaving a sharp edge.
<b>Additional Options</b>	Equipped with RPO U65 or UQS

If you encounter a vehicle with the above concern, install the rear window panel stowage compartment cover. Refer to Rear Window Panel Stowage Compartment Cover Replacement in SI for installation instructions.
