Service Bulletin

Subject: Auto-On Rear Window Defogger and Outside Rear View Mirror (OSRVM) Defogger Not Operating

| Brand: | Model: | Model Year: | | VIN: | | Engine: | Transmission: |
|---|---|---|---|---|---|---|---|
| Cadillac | ATS | 2013 | 2016 | | | All | All |

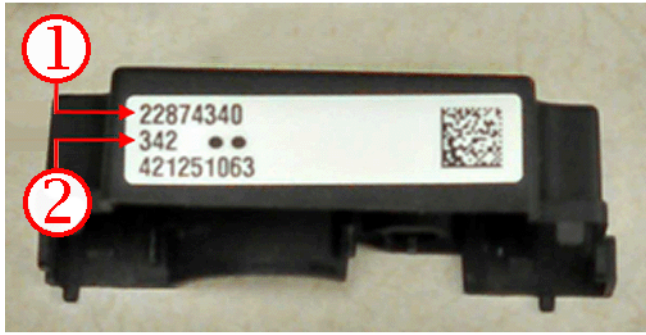
Radio Antenna Coil Label:

- (1) Original Part Number = 22874340
 - (2) Date Code; 2–digit “week”, 1–digit “year” example: week “34”, year “2012”
 - Supplier DUNS number
2. Replace the current radio antenna coil in the vehicle with radio antenna coil P/N 84043838. Record on the RO the P/N and the date code of the radio antenna coil removed from the vehicle (see picture above for locations) before installation of the new radio antenna coil.
 3. Remove the Supplement To The 2013-2016 Cadillac ATS Sedan Owner Manual from field action 15299.
 4. Contact the Techline Customer Support Center (TCSC) at 1-800-828-6860 (English) or 1-800-503-3222 (French) for instructions for how to reprogram the HVAC control module. Before contacting TCSC, the part number and date code of the original and the replacement radio antenna coil will be required. The TCSC will also need the RO number that the radio antenna coil was replaced on.
