Service Bulletin

PRELIMINARY INFORMATION

Subject: Intermittent Home Screen Icon/Navigation Overlay, Intermittent RVC Black Screen with Guidelines, Phone Pairing Not Included on the Phone Page, Routing Issues on Toll Roads in Mexico

Models: 2015 Buick Enclave
2015 Chevrolet Traverse
2015 Chevrolet Captiva
2015 GMC Acadia
Equipped with Radio RPO UI2, UI4, UI5, UI6, UI7 or UI8

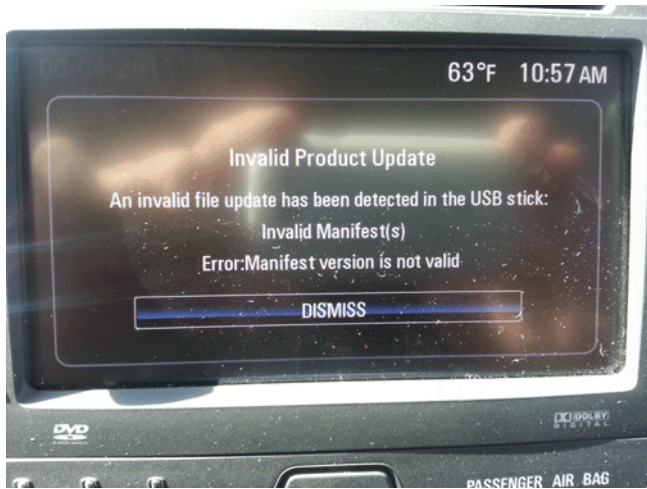
Note: If the following screen above is shown on the screen, the radio already has the latest calibration installed and no further action is required.
