# Service Bulletin

**Subject:** Delayed Engagement After Sitting With Engine Off - Torque Converter Fluid Drain Back

<b>Involved Region or Country</b>	North America and N.A. Export Regions
-----------------------------------	---------------------------------------

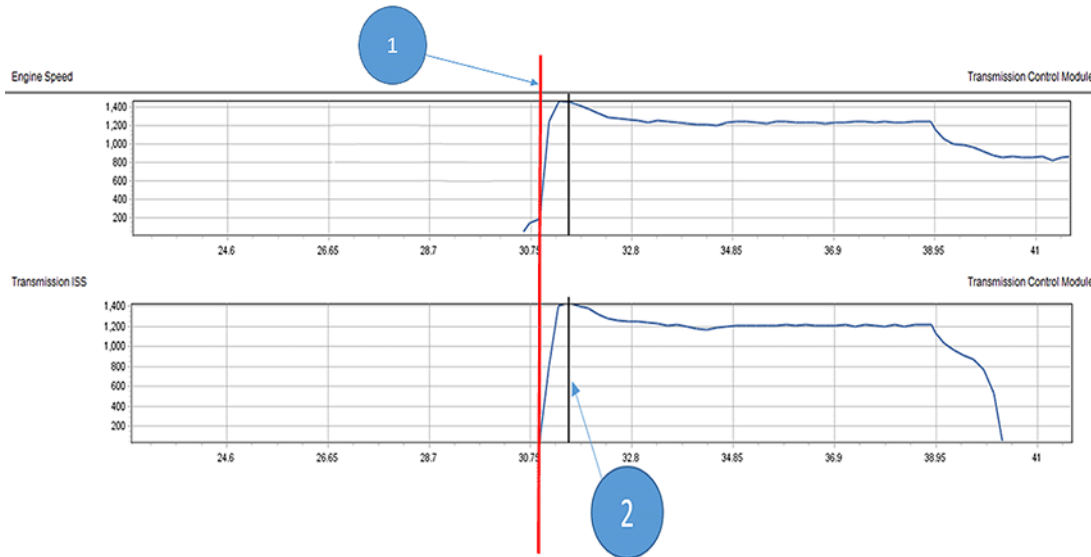
**Torque Converter Drain Down** is present if the time difference between engine speed ramping up (Pt. 1) and transmission input shaft speed is equal to engine speed (Pt. 2) exceeds 2 seconds.

The slide bar on the bottom left of GDS2 Screen can be used to aid in discerning time (Pt. 2 – Pt. 1) = Drain Down Time.

1. Using GDS and monitor engine RPM and transmission Input Speed Sensor (ISS) prior to starting the engine.
2. Start the engine with the transmission in park.
  - ISS should be equal to engine RPM in 2 seconds or less.
  - If ISS takes more than 2 seconds to equal engine RPM than follow the procedure for replacing the stator shaft support described in the service procedure below.
  - **DO NOT** replace the stator shaft support on vehicles taking 2 seconds or less for turbine shaft speed to equal engine RPM.

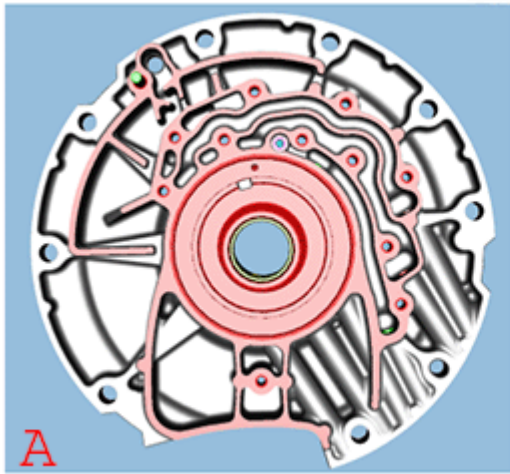
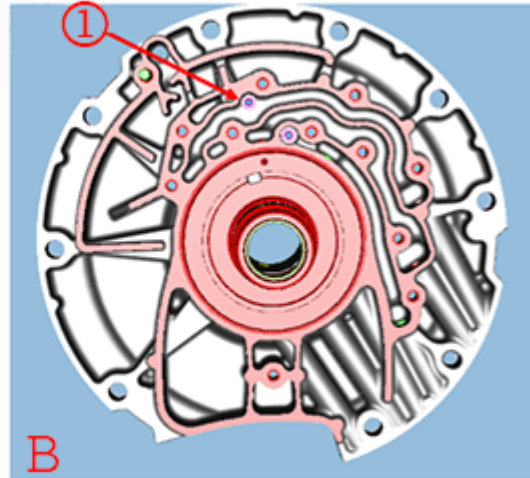
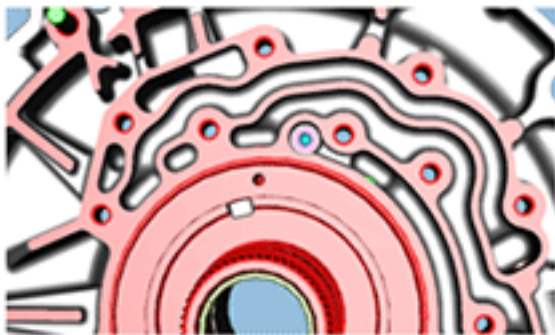
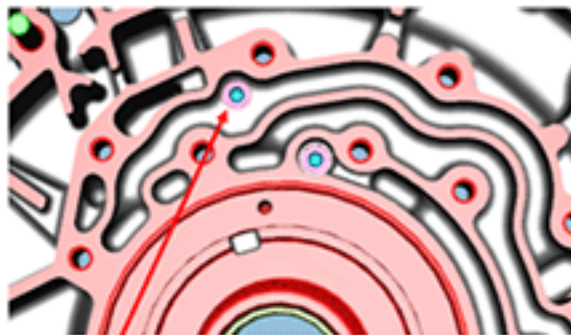
- A. Old stator support asm
- B. New stator support asm

**Note:** The new stator shaft support assembly has a second check ball (1) added (see illustrations).

Install a new stator shaft support assembly that includes an additional check ball. Follow the instructions below to replace the stator shaft support assembly.
