Service Bulletin

Subject: Engine Stall or Stumble - Replace Coil Connector

Attention: Vehicles equipped with 1.4L RPO LUJ/LUV turbocharged engine.

Brand:	Model:	Model Year:		VIN:		Engine:	Transmission:
		from	to	from	to		
Chevrolet	Cruze	2011	2014			LUJ/LUV	All

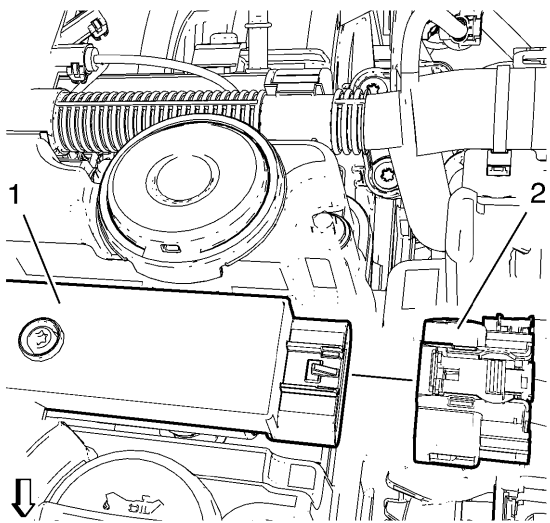
Condition	Some customers may comment that the engine stalls, stumbles, and/or has a hesitation when accelerating from a stop.
Cause	The ignition coil connector may have fretting on the terminals, causing a poor connection.

Ignition coil (1) and 7-pin ignition coil wiring harness connector (2)

Inspect the 7-pin coil pack connector for poor terminal contact or fretting. Replace connector with part number 19300958 if needed.

1. Inspect the 7-pin coil pack connector (2) for damage. If no damage is found, follow normal SI diagnostics.
2. If damage is found, replace the coil pack connector. Refer to *Ignition Coil Replacement* and *Splicing Copper Wire Using Splice Sleeves* in SI.
