# Service Bulletin

**Subject:** Turbocharger Noise and/or Malfunction Indicator Lamp Illuminated with DTC P2261

Brand:	Model:	Model Year:		VIN:		Engine:	Transmission:
		from	to	from	to		
Buick	Encore	2016				1.4L (LE2)	
Chevrolet	Malibu					1.5L (LFV)

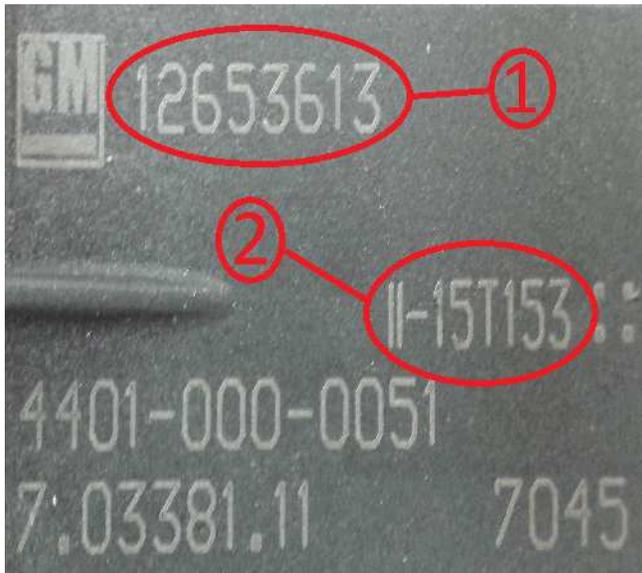
If diagnosis does not lead to an electrical concern, check the Julian date (2) on the turbocharger bypass valve.

- If prior to Julian date 15T327, replace the turbocharger bypass valve per SI repair procedure.
- If the Julian date is 15T327 and after, refer to SI diagnostics.
