Service Bulletin

Subject: Radio Inoperative - Blank Screen, No Audio, No Navigation and/or Lack of Audible Signal Chimes

| Brand: | Model: | Model Year: | | VIN: | | Engine: | Transmission: |
|---|---|---|---|---|---|---|---|
| Chevrolet | Impala (VIN 1) | 2014 | 2014 | Start of 2014 Production | November 1, 2013 | All | All |

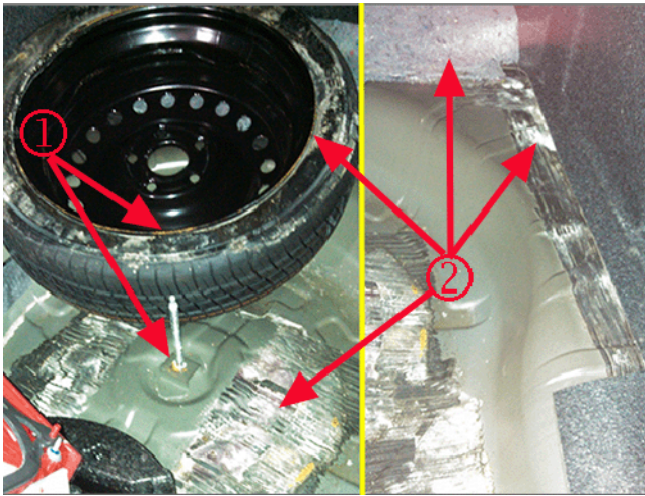
| Cause | The cause of the condition may be water damage that may have occurred due to tail lamp seals losing the ability to properly seal the trunk area. Two Recalls, #13426 and #14047, addressed replacement of the failed tail lamp seals, however an affected vehicle may not have had the recall repair completed yet, or the water damage may have taken place prior to the replacement the seals. |

Verify the condition, then remove trunk trim as necessary to inspect the trunk floor and spare tire for evidence of rust (1) or mold/residue (2).
