# Service Bulletin

**Subject:** Instrument Panel Upper Trim Pad Discoloration and/or Shiny Spot

Brand:	Model:	Model Year:		VIN:		Engine:	Transmission:
		from	to	from	to		
Chevrolet	Express	2016	2016	SOP	August 25, 2015	All	All
GMC	Savana	2016	2016	SOP	August 25, 2015	All	All

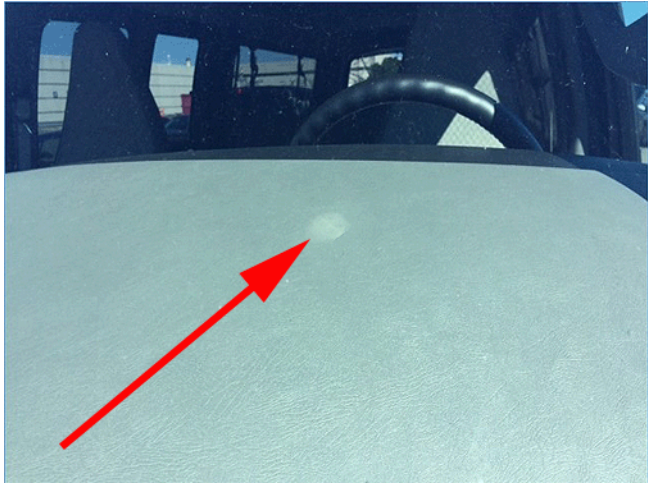
<p>Some customers may comment on a shiny spot and/or a white discoloration on the instrument panel upper trim pad directly in front of the instrument panel cluster.</p>
<b>Cause</b>	This may be caused by a tooling change within the production of the part.

If you encounter a vehicle with the above concern, replace the trim pad. Refer to Instrument Panel Upper Trim Pad Replacement in SI.
