Service Bulletin

PRELIMINARY INFORMATION

Subject: Difficult to Shift into Gear, Intermittent Gear Pop Out and/or Mushy Shifts (No Grind)

Models: 2014-2016 Chevrolet Corvette
Equipped with 7 Speed Manual Transmission (RPO MEL, MEP, MEK)

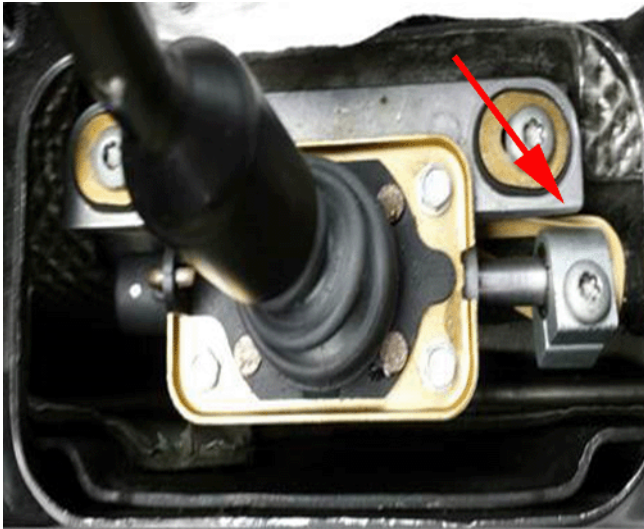
Note: There may be some variation on how and where the rubber band is placed. The above picture shows one possible location.

5. Before performing the shifter adjustment, make sure that the rubber band used to retain the shifter link during assembly is removed.

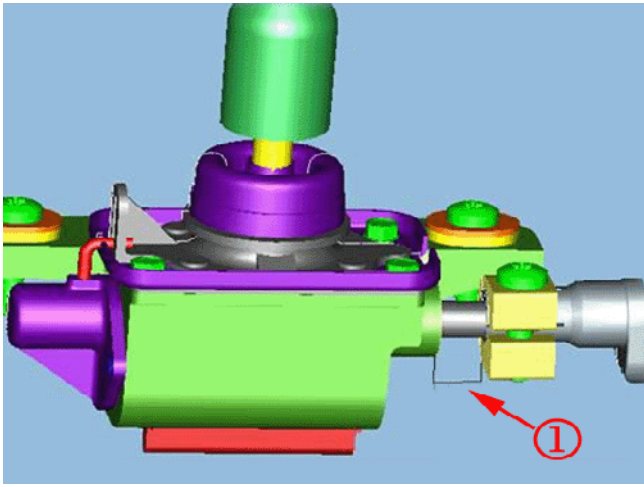
10.4. Inspect for proper alignment in the Neutral position. When the shift rod clamp is properly positioned the bolt will engage the slot/relief in the shift rod and be positioned approximately 15 mm from the shifter assembly as shown above (1).

10.5. Fix if incorrectly aligned by grabbing the linkage and push/pull to the proper gate.
