Service Bulletin

PRELIMINARY INFORMATION

Subject: Stop/Start System Malfunction or DTC P1064, P1065, P1066, P1068, P1069, P1070, P1074, P1077, P1078, P1079, P107A, P107B, P107C, P107D, P107E, P107F, P108A, P108B, P108C, P108D, P108E or P108F Set

Models: 2016 Cadillac ATS, CTS
Equipped with Stop/Start System (RPO KL9)

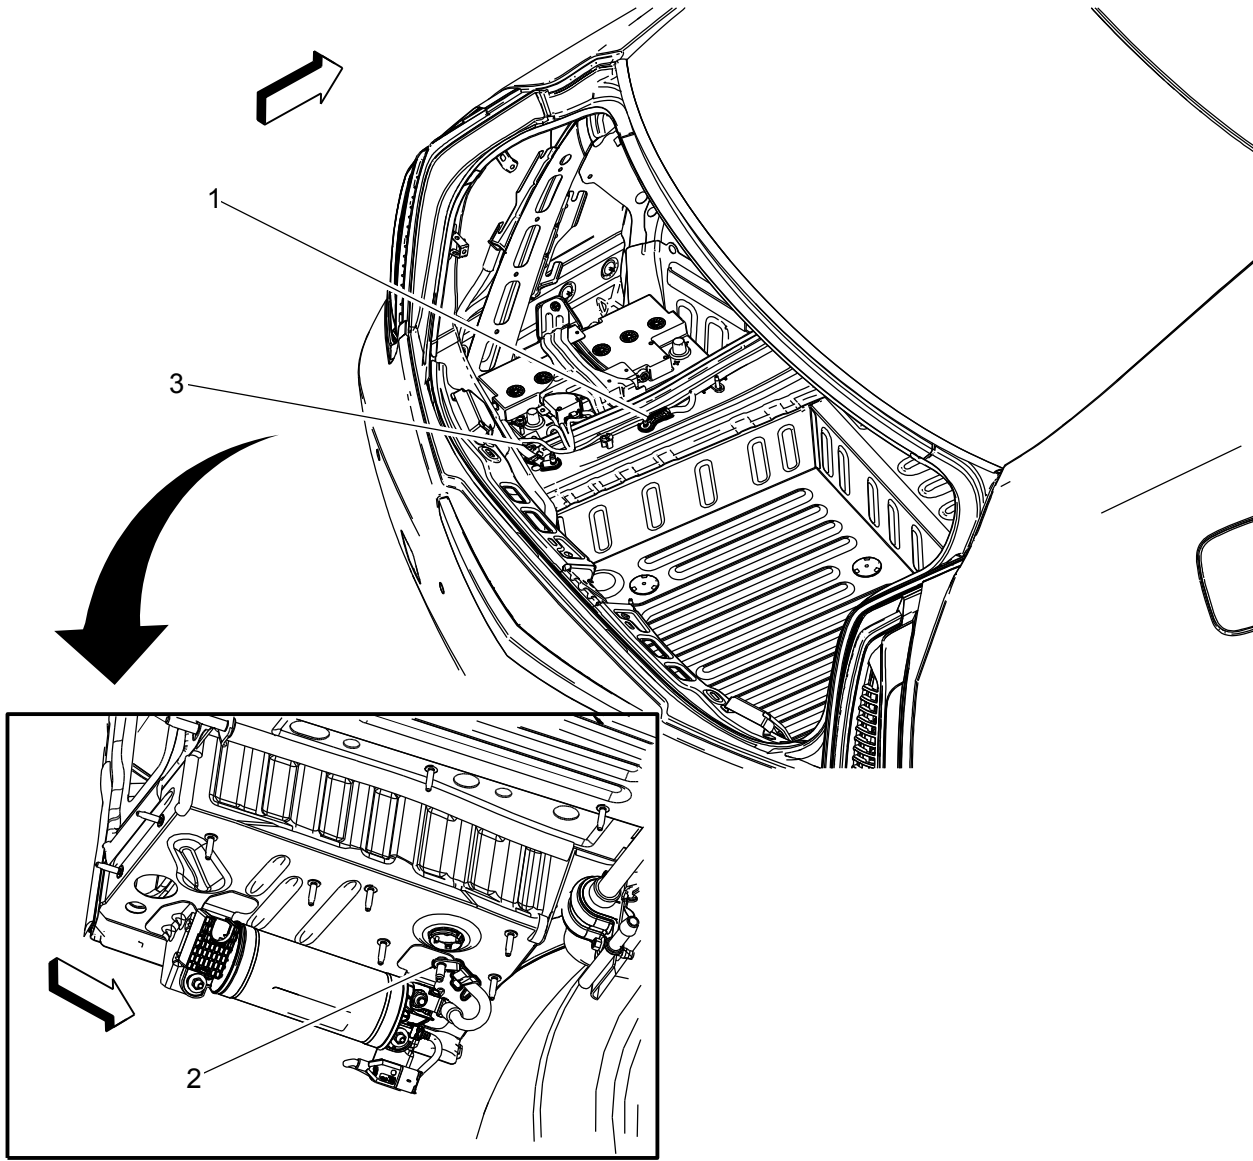
Some customers may comment that the check engine light appears on the cluster or that the Stop/Start feature is no longer functioning.

During diagnosis, the technician may find DTC P1064, P1065, P1066, P1068, P1069, P1070, P1074, P1077, P1078, P1079, P107A, P107B, P107C, P107D, P107E, P107F, P108A, P108B, P108C, P108D, P108E or P108F set as current or history.

Check the G400 (3) or G402 (2) ground nut for proper torque and then inspect and remove any paint on the G402 ground stud. If no issues are found, continue with Service Information (SI) diagnostics.
