Service Bulletin

Subject: Water Leak on Driver and/or Passenger Side Floor

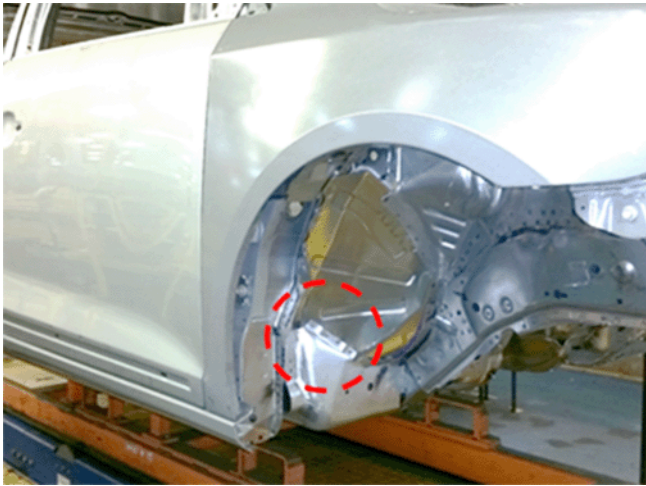
2. If the cause of the leak cannot be determined, remove enough of the rear portion of the front wheelhouse liner on the affected side(s) to access the outer lower hinge pillar. For LaCrosse, refer to the *Front Wheelhouse Front Liner Replacement* in SI. For Malibu, refer to the appropriate side *Front Wheelhouse Rear Liner Replacement* in SI.

Note: The right side hinge pillar is shown in the graphic above. Left side location would be similar.

3. With the front wheelhouse liner removed, visually inspect the outer lower hinge pillar for voids in the body sealer in the areas illustrated above.

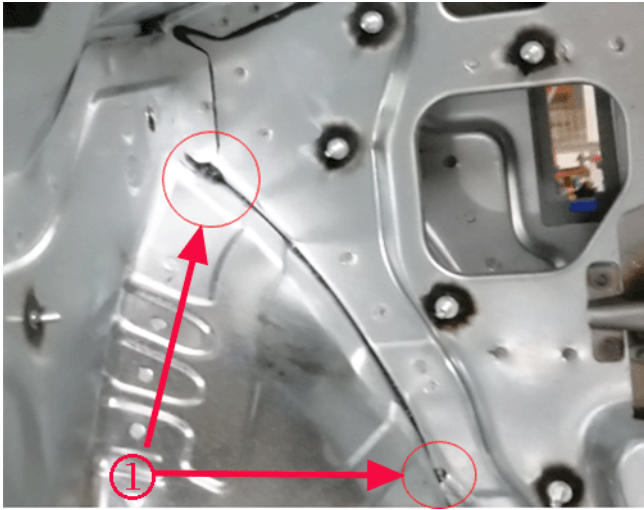
Note: The right side inner hinge pillar is shown in the graphic above. Left side location would be similar.

5. With the garnish removed and the carpet pulled back, visually inspect for voids (1) in the body sealer in the areas illustrated above.

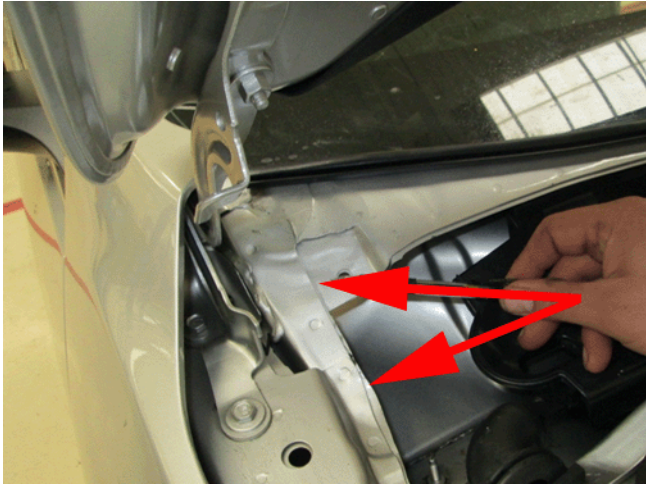
- With the air inlet panel removed, visually inspect for voids in the body sealer on the affected side in areas illustrated above.
- If there are voids found in the body sealer, apply high tech clear seam sealer, Kent Industries P/N P10200*, to the affected areas.
- After all voids are filled, perform a waterleak test to verify the condition is corrected. Refer to *Waterleak Test Preparation* in SI.
- Reinstall the air inlet grille panel and any parts/trim removed for access to repair areas.
