Service Bulletin

Subject: Audio System Speaker Rattle, Buzz Noise, Poor Sound When Playing Radio or Other Music Source

Brand:	Model:	Model Year:		VIN:		Engine:	Transmission:
		from	to	from	to		
Chevrolet	Colorado	2015	2016			All	All
GMC	Canyon	2015	2016			All	All

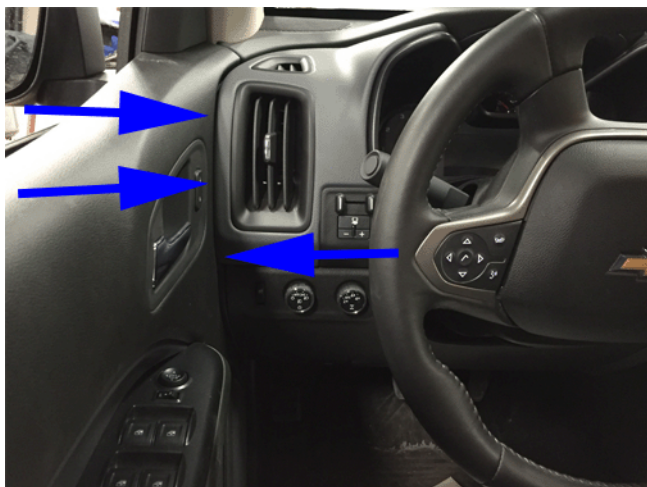
Loose Trim, Panel to Panel Contact

An interface may cause a rattle or buzz (for example, between a door and instrument panel).

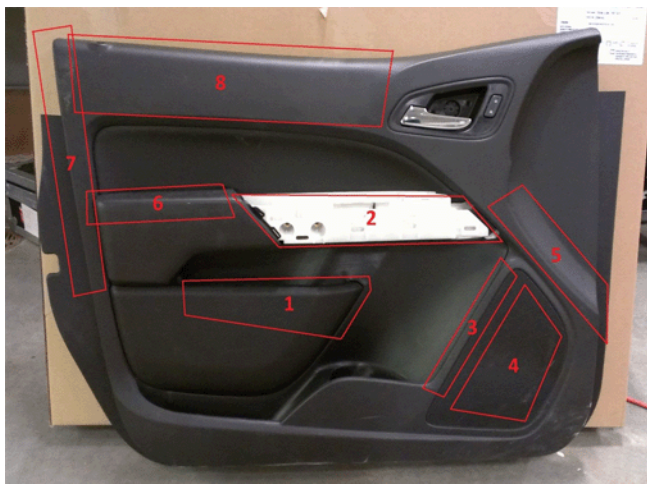
Door Trim/Water Deflector/Harness Rattle

If the rattle is heard within the door trim, check the locations shown above by depressing the trim with your hand. If the sound changes or the rattle/buzz decreases when pressure is applied, follow the steps below.
