Service Bulletin

PRELIMINARY INFORMATION

Subject: Floor/Carpet Wet at Front Passenger Side Under Dash, or at Any Front/Rear Footwell Area

Models: 2011-2016 Chevrolet Caprice PPV
2014-2016 Chevrolet SS

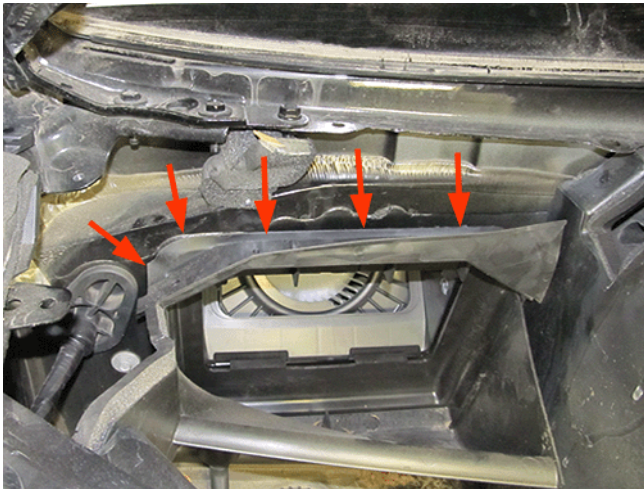
- Water intrusion in the seam (1) between the HVAC case and the cowl.

3. Apply windshield urethane, such as *Kent Industries Speed Set Windshield Sealant P/N P10545, or equivalent, to the seam to seal the top of the HVAC case to the cowl.

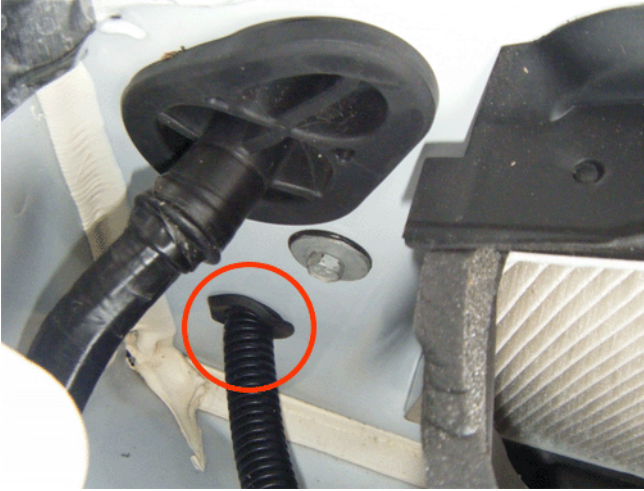
- For some police equipped vehicles, water may run on the wire harness exiting the HVAC case, then follow along the conduit into a grommet/hole (shown circled in the graphic above) in the cowl, and finally run into the vehicle interior.

- 5.3. Apply windshield urethane to the cowl and grommet to seal the wire harness to the hole through the cowl.
- 6. Reinstall the upper and lower air inlet grille panels. Refer to *Air Inlet Grille Panel Replacement (Lower Panel)* in SI.

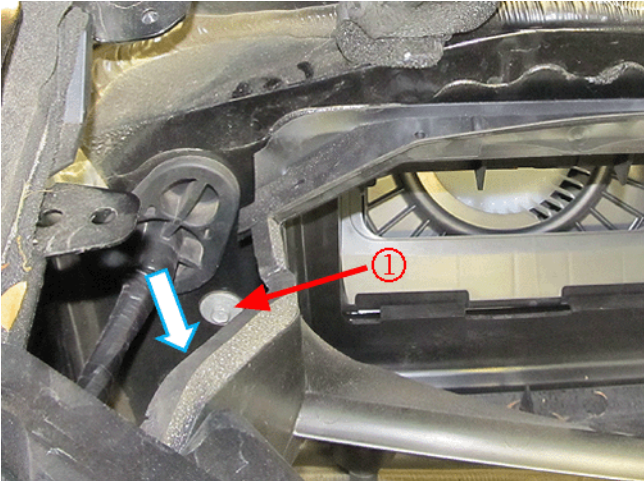
4. Inspect the cowl area outside the HVAC case for the possible existence of a wiring harness associated with certain police equipped vehicles. If equipped, the grommet/hole location for the harness will be just below the bolt (1) shown in the graphic above.

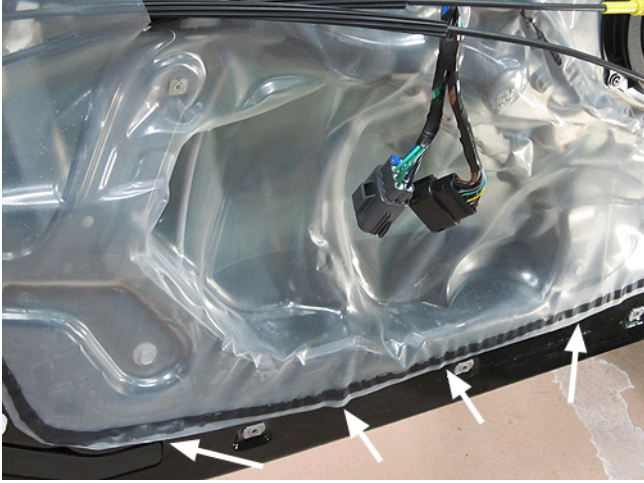
The cause of this condition may be that water, normally being channeled through a side door, may bypass an improperly sealed water deflector and create a leak path into the vehicle. Because of the increased mirror/window switch wiring harness content, this condition most commonly occurs at the driver door, but may occur at any front or rear side door.

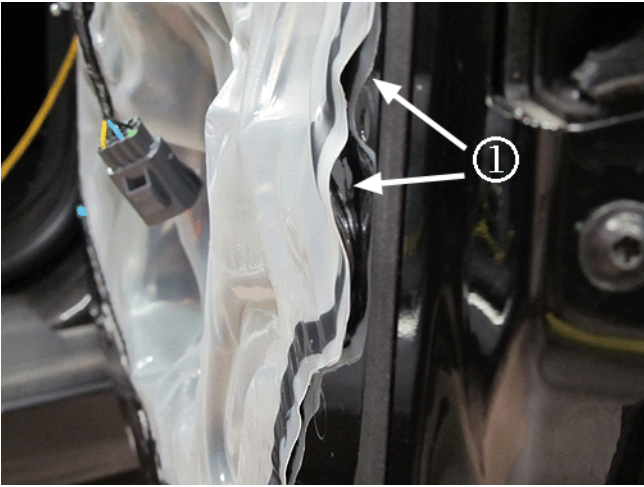
2. Inspect the door water deflector for any puckers/gaps (1) where the butyl adhesive may have pulled away from the inner door surface.
