Service Bulletin

Subject: Loss Of Oil Pressure On LT1 Camaro And CTS-V Only

Models: 2016 Cadillac CTS-V
2016 Chevrolet Camaro SS
Built with the 6.2L LT1, LT4 engines

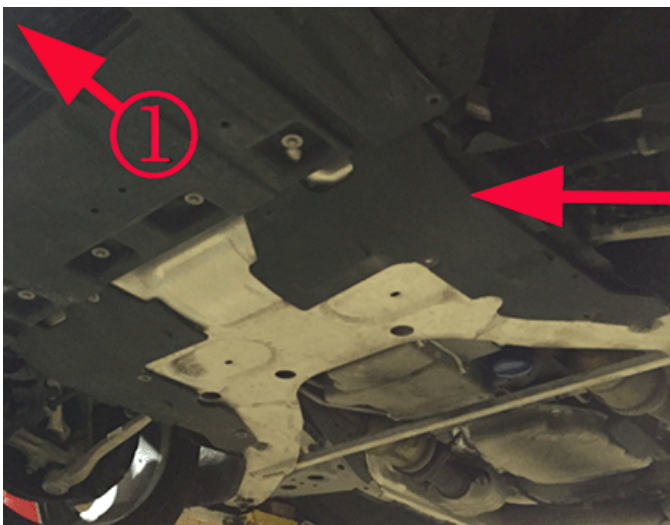
Front of vehicle (drivers side) remove attachment clips holding Aero shield and remove shield.

1. Is the front of the vehicle

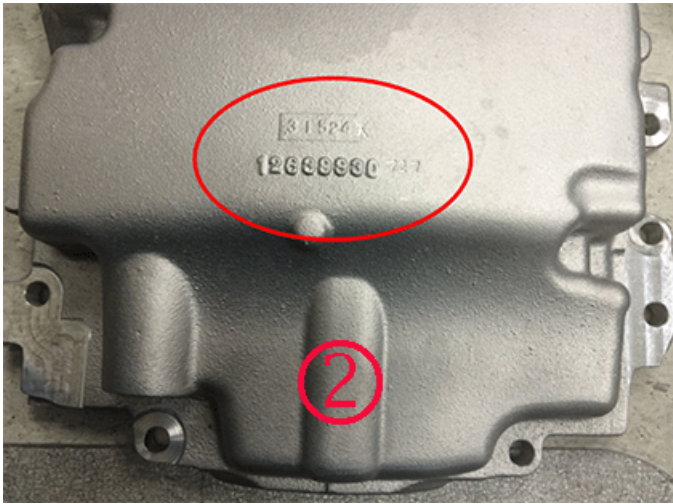
Pan part number will be about 6" behind the crank pulley, just rearward of the first "step up" surface.

Wiring loom may need to be pushed aside to view.

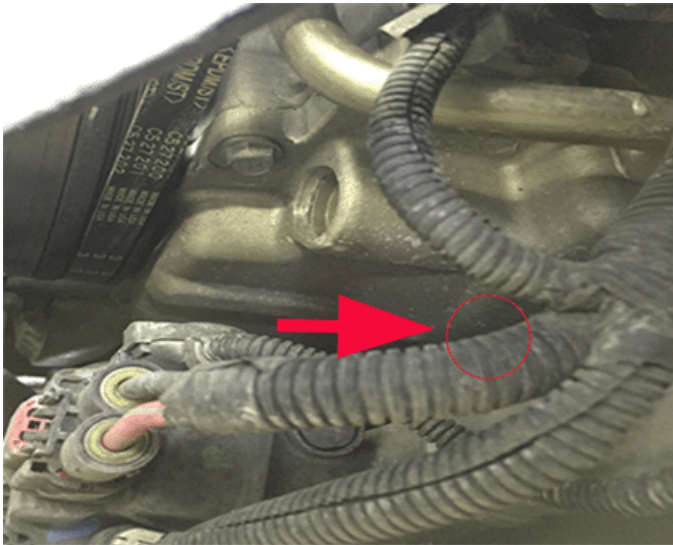
If the pan has raised marking in this location the pan will need to be repaired (see repair procedure). If markings are not present vehicle is good and can be released.

The arrow is showing where to look to see the numbers.

1. Follow SI service procedure to remove oil pan (Document ID: 4205917).
2. Inspect pickup tube to see if dislodged.
3. If dislodged, replace oil pan assembly, do not repair.
 1. If pick up tube is dislodged, main bearings will need to be inspected.
4. 4. If intact, continue with steps below
 - a. Pickup tube is considered intact if bead is less than 5.0 mm from casting.
5. Remove (2) bolts retaining the pickup tube and discard bolts.
6. Clean bolt holes with shop air and brake clean to remove residual oil.
7. Apply Loctite 243 to threads of (2) new bolts (P/N 11519374).
8. Install bolts and torque to 9.0 N-m.
9. Follow SI service procedure to install oil pan (Document ID: 4205917).
