Service Bulletin

PRELIMINARY INFORMATION

Subject: BAS+ (HYBRID) eAssist Drive Motor Generator Battery Module (Powerpack)

Models: 2012 - 2016 Buick Lacrosse, Regal
2013 - 2014 Chevrolet Malibu ECO
2014 - Chevrolet Impala
All equipped with eAssist (RPO HP6)

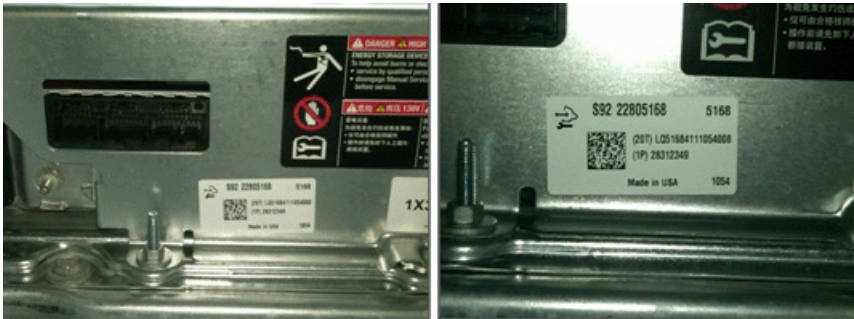
- The parts department fax number
 - The Powerpack serial number (Battery Identification Number)
9. The Battery Identification Number (BIN) tag is located on the side of the assembly cover. Locate the tag and record the 16 digit Battery Identification Number. The BIN number begins with digits "20T" (See Photo Below). If the Generator Control and Battery Module is not out of the vehicle yet, you can find the assembly ID number by installing the MDI and using GDS2. Access the Battery Energy Control Module menu and look under the ID Information section for the sixteen digit number. It will be listed under the parameter: Hybrid Battery Pack Identification Number. You will need to record the serial number and supply it to TAC when requesting a Powerpack or Battery Sections.
