Service Bulletin

PRELIMINARY INFORMATION

Subject: Steering Feels Loose And/Or Excessive Lash (Adjust Steering Gear)

Models: 2016 Chevrolet Silverado 2500/3500
2016 GMC Sierra 2500/3500
With Digital Steering Assist (RPO NV8)

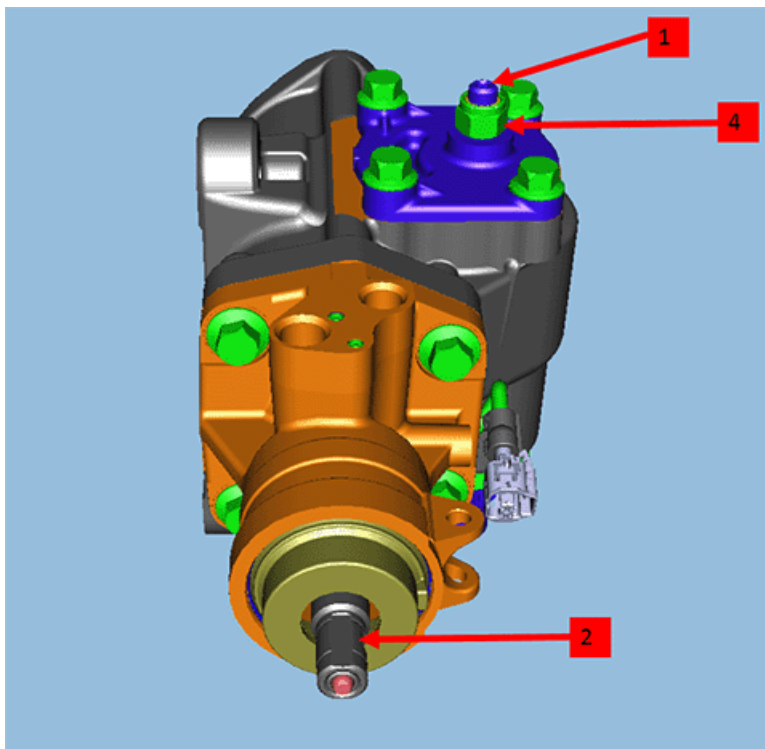
Some owners may comment the steering feels loose or has excessive play. This concern could be caused by an incorrect Pitman Shaft Over-Center Preload Adjustment.

2. Loosen the steering gear pitman shaft lash adjuster nut (4).
3. Turn the steering gear pitman shaft lash adjuster screw (1) counterclockwise until fully extended.

4. Turn the steering gear pitman shaft lash adjuster screw clockwise 1 full turn.
5. Rotate the steering gear input shaft (2) from stop to stop using a socket designed for the input shaft geometry, or crows foot with ratchet while counting the number of turns.
6. Starting at either stop, turn the steering gear input shaft (2) back half the total number of turns counted previously. This is the center position.
