Service Bulletin

PRELIMINARY INFORMATION

Subject: Power Folding 3rd Row Seat Does Not Fold Down Completely

Models: 2015-2016 Cadillac Escalade Models
2015-2016 Chevrolet Suburban, Tahoe
2015-2016 GMC Yukon Models
With Power Folding 3rd Row Seat (RPO AS8)

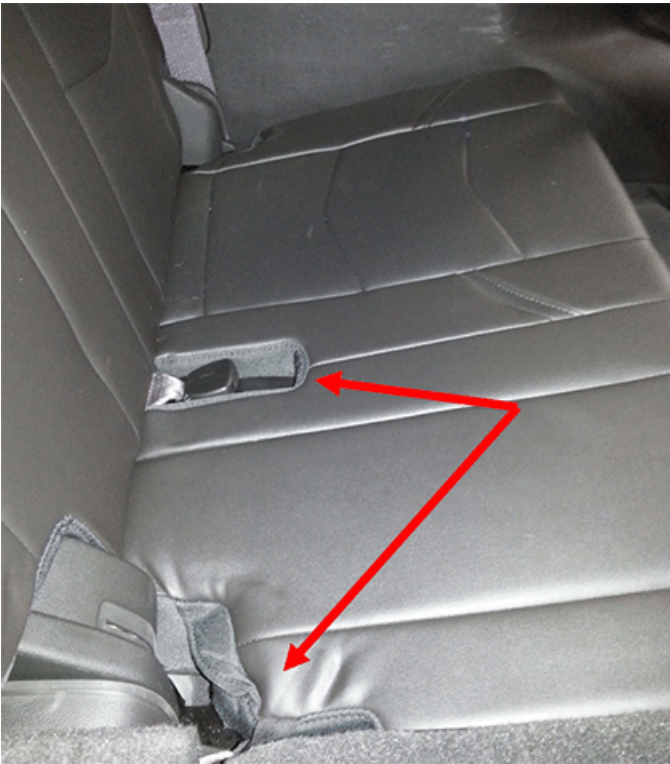
1. When the 3rd row seat is folded down the seat base/cushion moves down very close to the floor, leaving little clearance between the bottom of the seat cushion and floor/carpet. Any items such as books, blankets, toys, shoes, etc., under the seat may not allow the seat to fold down completely. Remove any items from under the 3rd row seats and retry.
2. If the center seat belt from the roof is connected to the seat belt buckle or any of the seat belt buckles not properly stowed in the seat cushion pockets, these items can contribute to the issue. Disconnect the center seat belt from the seat and properly stow the seat belt buckles, as shown below, and retry.

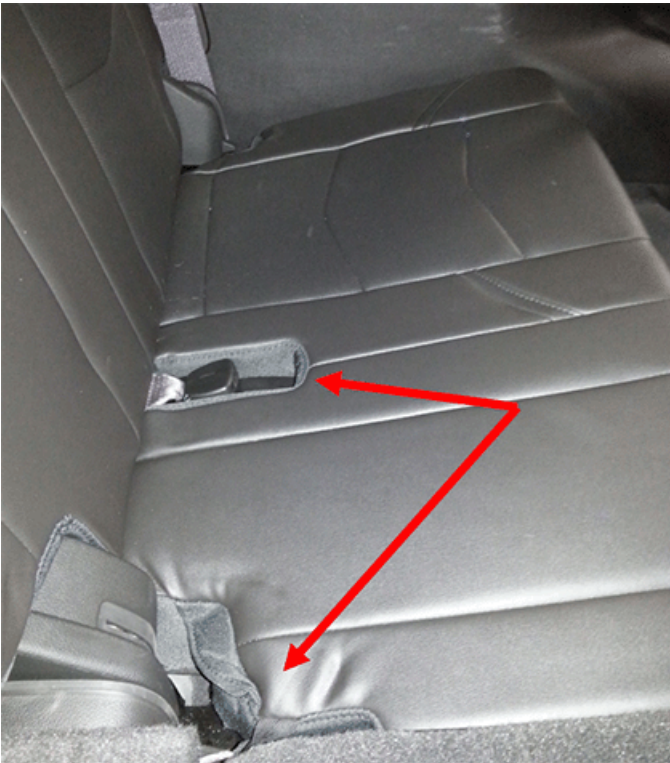
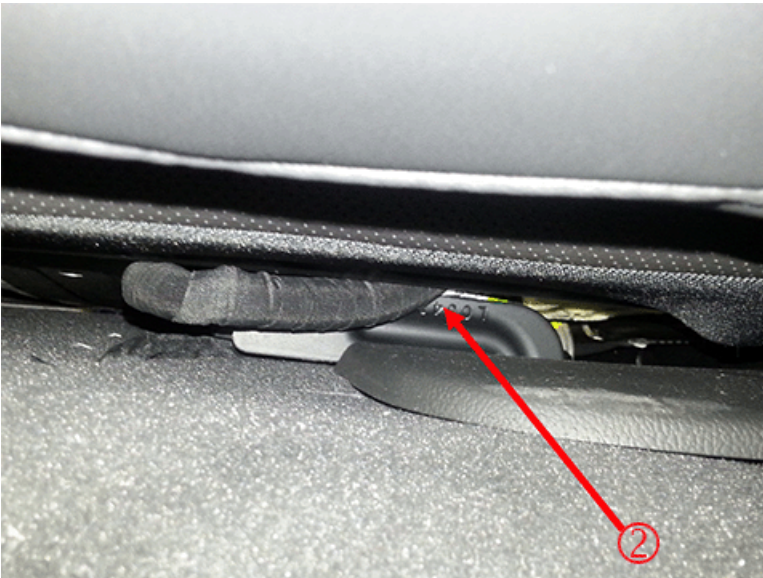
3. If the seat harness, under the left side of the 60% seat, is not properly routed (1) or the seat connector is not properly attached to the bracket, this may obstruct the seat from moving down flat on the floor (2).

If the seat harness is out of position , reroute the seat harness as shown below (3) and properly secure the seat connector to the bracket as shown (4). The use of a zip tie may be necessary to hold the connector in place. After making repairs, power fold the 3rd row seat down and make sure the seat bottom is not contacting the seat harness, connector or bracket as shown below.

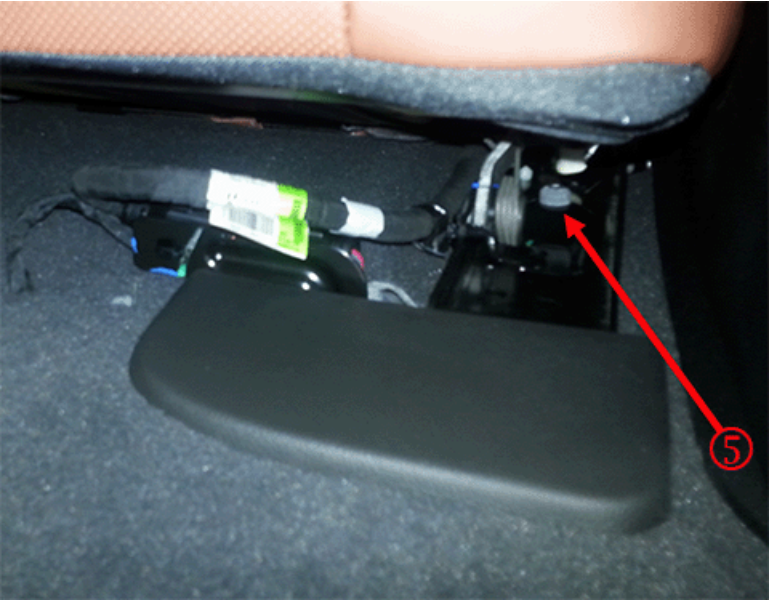
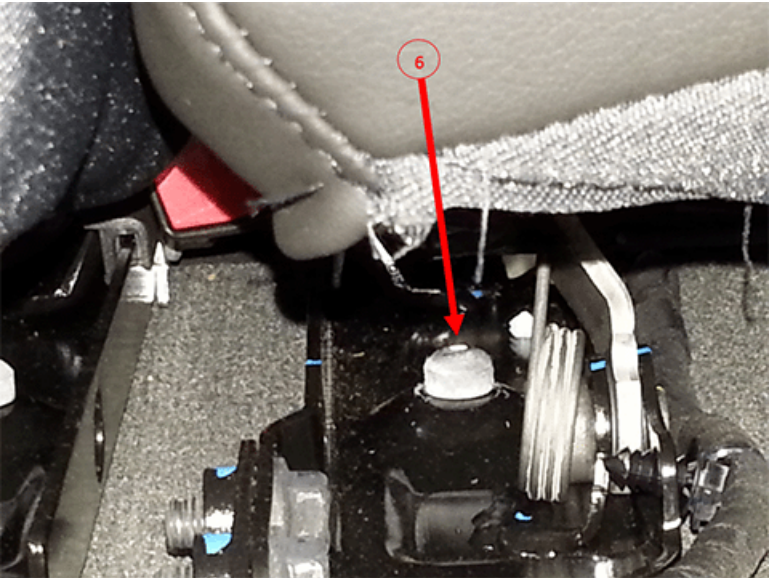
4. If after performing the above suggestions and the 60% side of the seat does not fold down even with the 40% side, remove the two rubber bumpers

from the 60% seat rails, as shown below (5) left rail and (6) right rail. After removing the rubber bumpers install a piece of Kent Automotive BRS Flocking tape P/N KT13487, or equivalent, in place of the rubber bumper. Cut the tape approximately 1" to 1 1/2" square and install on the seat track, in place of the rubber bumper that was removed.

After removing the two rubber bumpers and installing the flocking tape, cycle the seat up and down several times with the engine running. After repairs are complete, retry to confirm the issue is repaired.
