Service Bulletin

Subject: Water Intrusion - Forward Lamp Harness - Engine Cooling Fan Inoperative - DTC P0480 and/or P0691

Models: 2016 Chevrolet Camaro
Equipped with 3.6L Engine (RPO LGX)
Equipped with 2.0L Engine (RPO LTG)

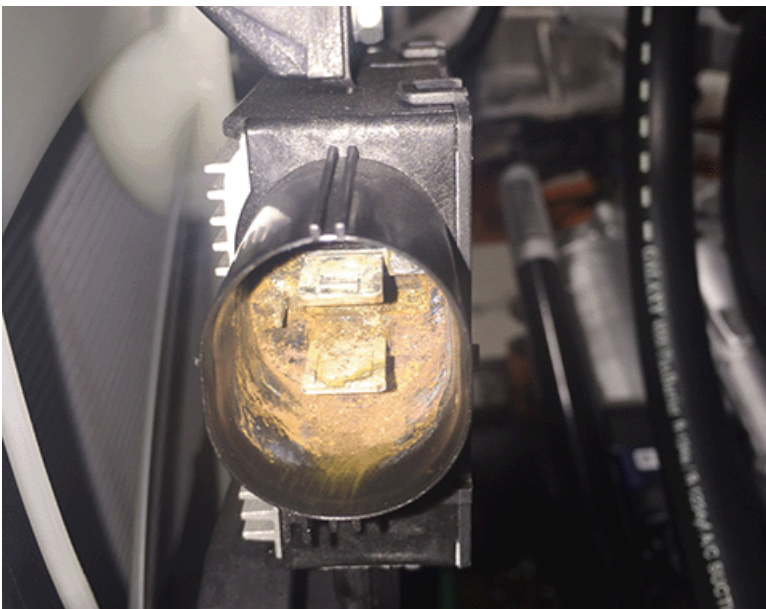
If the wiring harness is stretched, or side loaded, where the cooling fan module connector plugs in, this may allow water to wick down the harness, past the weather pack seals, and into the connector itself.

As time goes on, this water may corrode the terminals inside the connector and/or the harness itself as seen in the two photos below.

As the corrosion builds, this may cause the engine cooling fan to become inoperative altogether.

If this concern is encountered, dealership technicians are to first inspect the forward lamp wiring harness to cooling fan module connector for the presence of moisture and/or corrosion.

If either is found, the fan control module AND the forward lamp harness will both need to be replaced.
