Service Bulletin

PRELIMINARY INFORMATION

Subject: Service Charging System Message / SES MIL / P0621 and/or P0622

Models: 2011-2014 Chevrolet Silverado 2500/3500
2011-2014 GMC Sierra 2500/3500
With 6.6L Diesel Engine (RPO LML)
With Dual Generators (RPO K76)

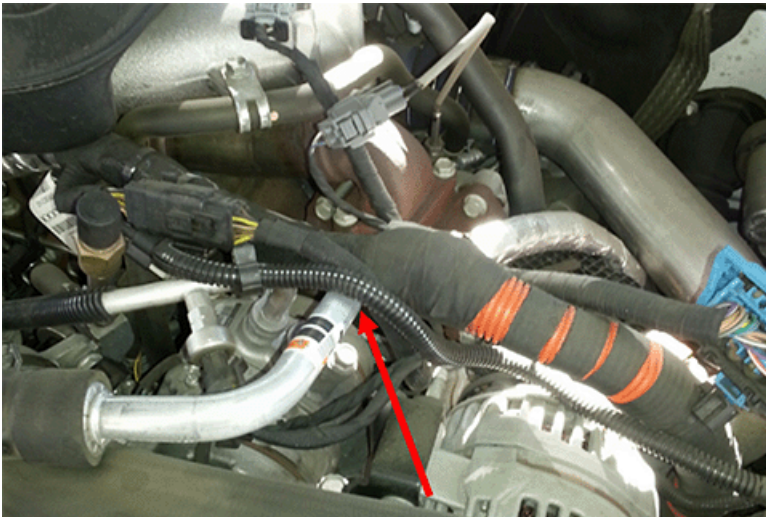
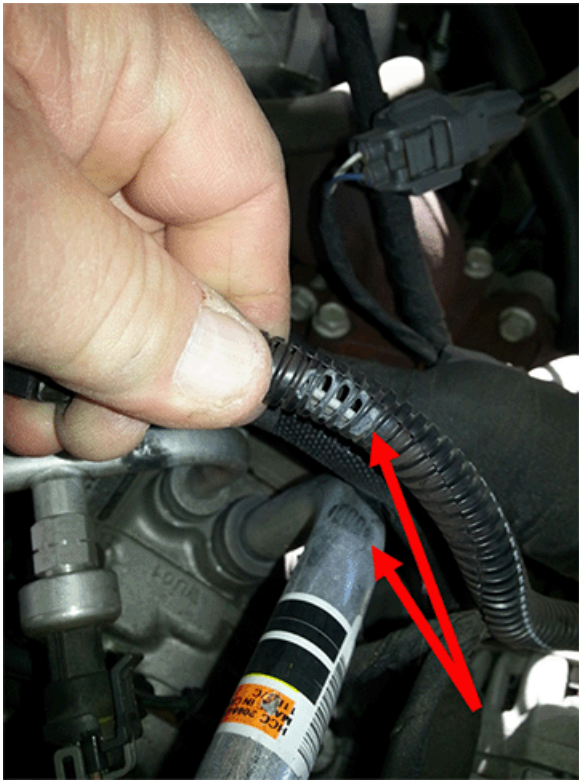
Some customers may comment of a Service Charging System message or SES MIL

When checking for DTC's the ECM may have set a P0621 and/or P0622.

These concerns could be caused by the generator wiring harness rubbing on the A/C compressor line and shorting the circuits, as shown below.

Inspect the generator wiring harness for chaffing and repair as necessary.

Install additional conduit to protect the wiring harness from future issues.
