# Service Bulletin

**Subject:** Clunk Noise After Shifting From Reverse To Drive Or Drive To Reverse And Then Accelerating

**Models:** 2007-2009 Cadillac SRX  
2007-2011 Cadillac STS  
2008-2013 Cadillac CTS  
2010-2015 Chevrolet Camaro  
RWD only, equipped with 6L45 or 6L50 (RPO MYA, MYB) Automatic Transmission

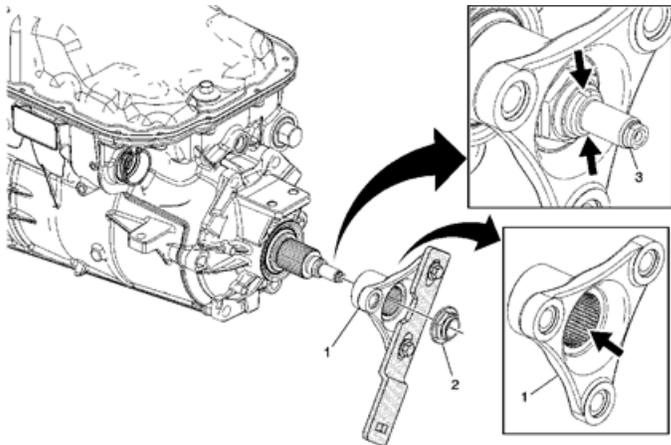
This condition may be caused by the torque on the propeller shaft flange nut or movement between the flange and the transmission output shaft.

Apply thread locker to the transmission output shaft flange splines and a new front propeller shaft flange nut following the procedure below.

The existing output shaft and output shaft flange can be re-used and does not require replacement. A new front propeller shaft flange nut should be used.

### Callout 1

Component Name: Propeller Shaft Transmission Flange

1. The output shaft flange splines must be thoroughly clean and dry before installing the flange

2. Apply GM P/N 89021297 (Canadian P/N 10953488) evenly across the width and length of the flange splines and install the flange onto the transmission output shaft.
3. Sufficient application of adhesive to every tooth on the flange will leave excess adhesive on the output shaft after installation. If no excess is observed, reapply adhesive. Remove excess adhesive.

## Callout 2

Component Name: NEW Front Propeller Shaft Flange Nut

1. The output shaft nut threads must be thoroughly clean and dry before installing the nut.
2. Apply GM P/N 89021297 (Canadian P/N 10953488) across the width of the nut threads, prior to tightening and staking.

Tighten 55 N·m (41 lb ft).

## Callout 3

Component Name: Output Shaft

**Caution:** Stake the flange nut onto the output shaft. Use the two staking grooves on the shaft to locate the staking points. Failure to stake the flange nut may result in damage to the transmission.
