Service Bulletin

Subject: Pop Noise From Fuel Tank After a Cold Start or EVAP Purge Event

Models: 2010 -2017 Chevrolet Equinox
2010-2017 GMC Terrain

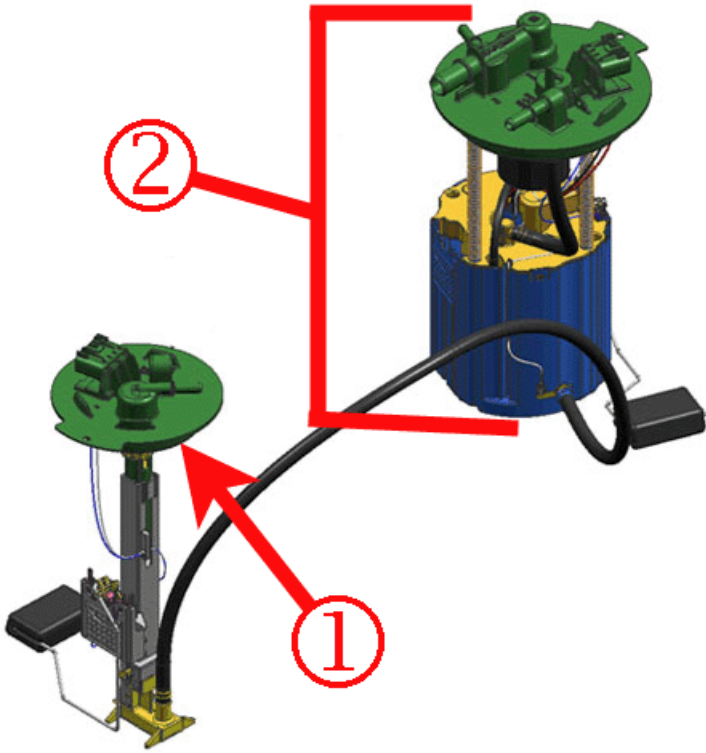
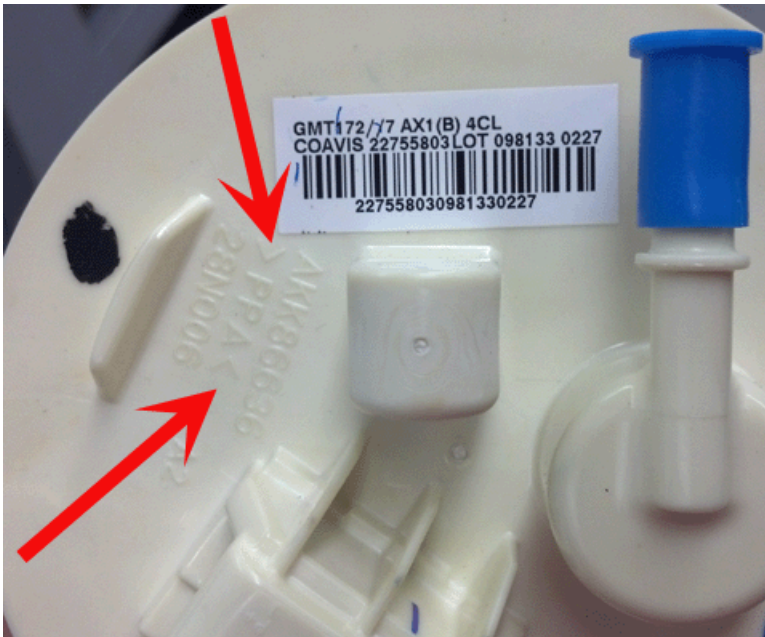
The cause for this concern is the auxiliary fuel pump in the left side of the fuel tank changing height (spring loaded leg).

1. Flange location of the auxiliary fuel module (Fuel Pump Auxiliary)
2. Primary Pump NOT the correct component to replace (Fuel Pump)

After ordering the auxiliary fuel pump, remove it from the box and verify the letters "PPA" are cast into the top of the fuel pump flange.

This is the revised auxiliary fuel pump designed to correct the pop/popping noise. The original auxiliary fuel pump has "POM" cast into the flange.

Important: The condition described in this PI applies only to the auxiliary fuel pump module assembly. The Parts Catalog calls this auxiliary pump component the "Fuel Pump Auxiliary" which is the correct part for this repair. Replacing the primary fuel pump module assembly would NOT correct this noise condition. The parts catalog calls this primary pump component the "Fuel Pump" which is the incorrect part for this repair.
