Service Bulletin

PRELIMINARY INFORMATION

Subject: Drone Noise At 1900-1950 RPM's

Brand:	Model:	Model Year:		VIN:		Engine:	Transmission:
		from	to	from	to		
Chevrolet	Malibu	2016	2017	All	All	LFV	All

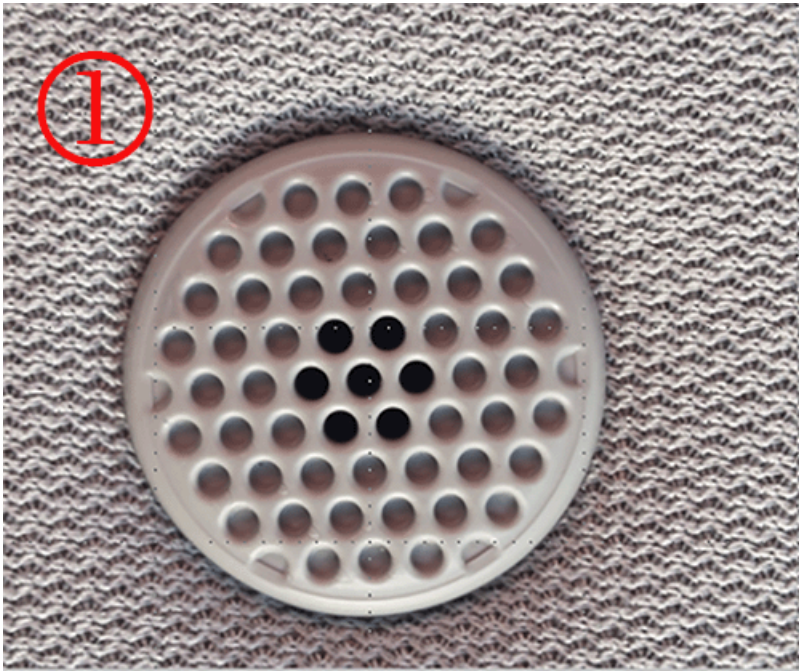
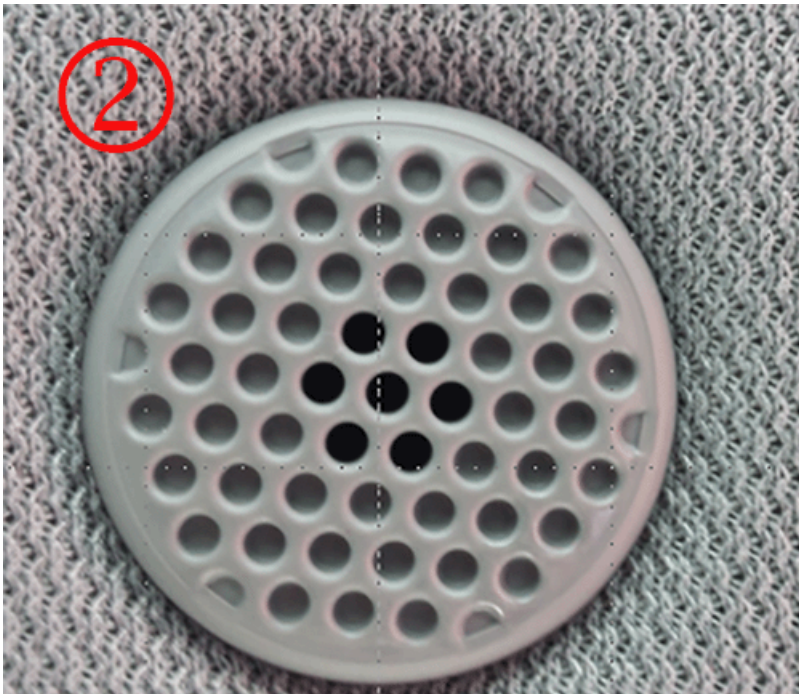
1. Verify that the ANC module fuse is good.
2. Verify that the ANC module connector terminals have proper tension and that the connectors are fully seated.
3. Play an audio source and verify that each speaker has audio by fading and balancing the output to each speaker individually.
4. Lower headliner to access the three ANC microphones.
 - A. Verify terminal tension on ANC Microphone connections.
 - B. Each Microphone should have 105k-110k OHM's of resistance.
 - C. The microphone should be centered in the bracket. See the examples below of properly aligned and fitted grill covers.

Note: Shining a white LED light into the grill holes should reveal a centered blue dot. The blue dot is the diaphragm of the microphone and if it is not centered a realignment of the mic will be required.

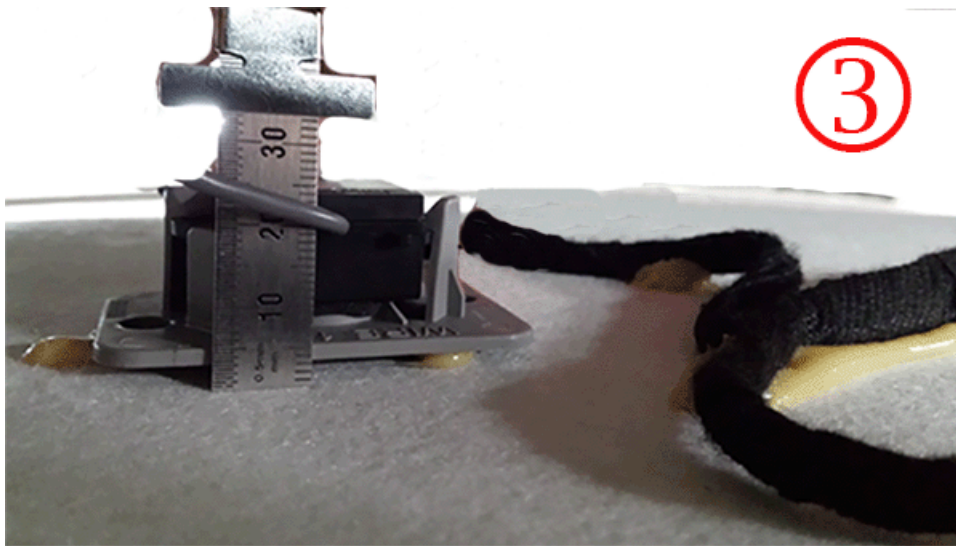
D. The microphone bracket needs to be flush to the Headliner.

Gaps are very bad for ANC performance. The adhesive material may need to be removed and the bracket re-bonded to headliner substrate.

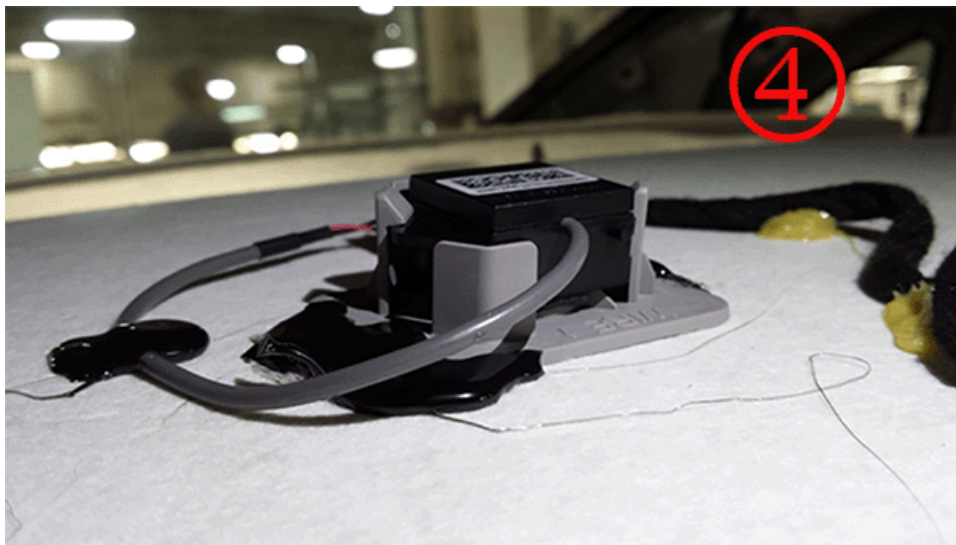
After repair using available hot glue. This has a good fit to headliner substrate (no gap).
