# **Service Bulletin**

#### Subject: Exhaust Leak, Noisy Exhaust, Rattle, Rumble and/or Noise Mid-Vehicle

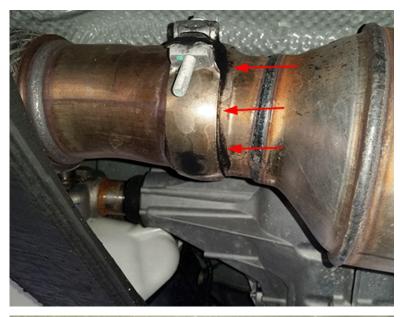
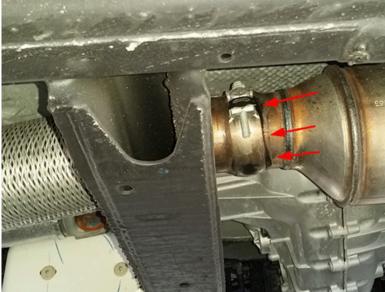
Involved Region or Country	North America
Additional RPO/s:	N/A
Condition	Some customers may comment on an exhaust leak, noisy exhaust, or noise mid-vehicle. The noise may be described as a rattle or rumble. May be most noticeable on a cold start.
Cause	This condition may be caused by an unseated pipe to pipe mid-joint connection as seen below

- 1. Remove and discard the exhaust band (Norma) clamp.
- 2. Install and position a new exhaust band (Norma) clamp to the pipe joint.
- Firmly push and maintain the pipes together while tightening the exhaust band (Norma) clamp bolt. Tighten the clamp bolt to 30 Nm (22 lb. ft.).
