Bulletin No.: PIP5443

# Service Bulletin

Subject: Diagnostic Tip For Avoiding Turbo Charger Damage During Under Hood Service Work

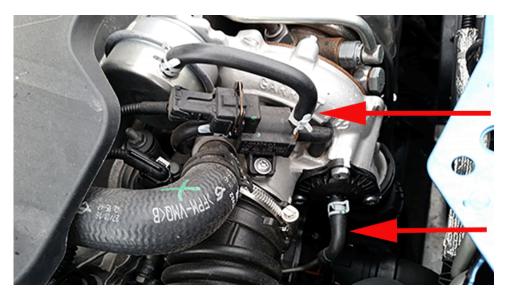
Turbochargers have been returned under warranty with damage to the wastegate Actuator Solenoid vacuum port fittings and Bypass Valve port fittings.

Pictured below are areas that are susceptible to damage during service.

Currently, service parts are available for the bypass valve, wastegate solenoid and waste gate actuator in kits.

Do not replace the turbocharger assembly for damage to the components contained in the related kits.
