Service Bulletin

PRELIMINARY INFORMATION

Subject: RKE / Passive Entry And Start / No Audio / SWC / Touch Screen / Display Blank/ Rear Wiper And Rear Power Windows Inoperative / Dead Battery / Service Tire Pressure System / SES MIL DTC B3101 B144C C0710 C0544 P0106 P0107 P2122 P2123 P2127 P2128 P2138 U0028 U0029 U0077 U0126 U0151 U0415 U1548 U1549 U154A

Models: 2015-2017 Cadillac Escalade Models
2014 Chevrolet Silverado 1500
2015-2017 Chevrolet Silverado, Suburban, Tahoe
2014 GMC Sierra 1500
2015-2017 GMC Sierra, Yukon Models

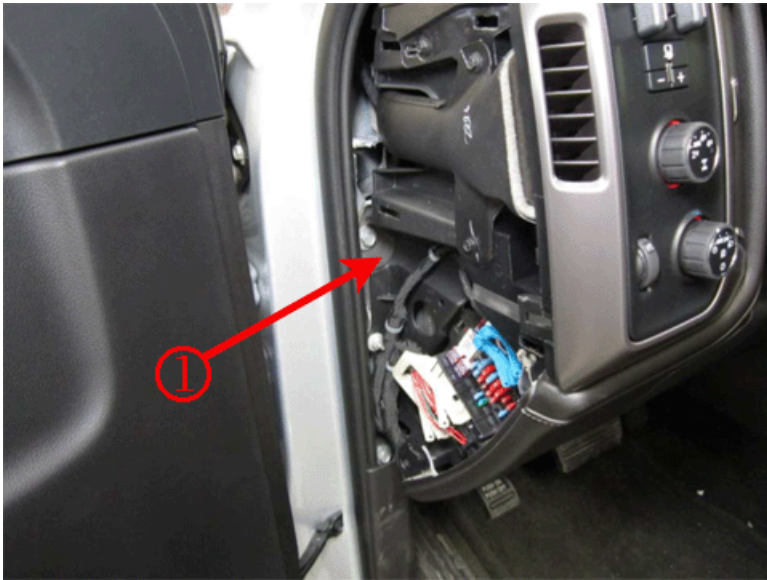
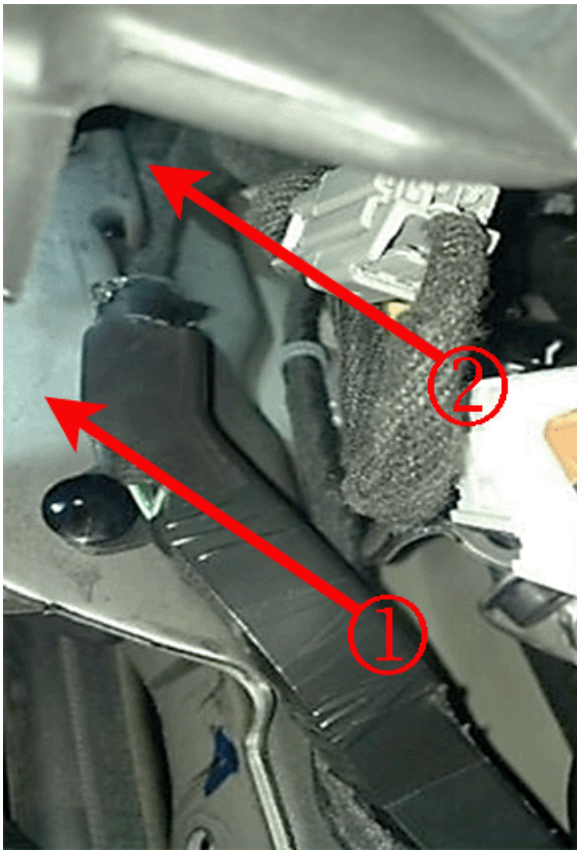
These concerns could be caused by the dash harness (2) being pinched between the left I/P dash mounting bracket (1) and the body, as shown below. In many cases, the complete harness is not pinched and may not be as apparent as shown in the below photo. When inspecting for a pinched harness, make sure the harness can be moved freely away from the bracket to body interface.

To repair this concern, loosen the left I/P dash mounting bracket bolts and pull the harness free. Open the harness and repair any damaged wires as necessary.
