Service Bulletin

PRELIMINARY INFORMATION

Subject: Click Rattle Or Squeak Noise From Dash Area

Models: 2015 - 2017 Cadillac Escalade Models
2014 Chevrolet Silverado 1500
2015 - 2017 Chevrolet Silverado, Suburban, Tahoe
2014 GMC Sierra 1500
2015 - 2017 GMC Sierra, Yukon Models

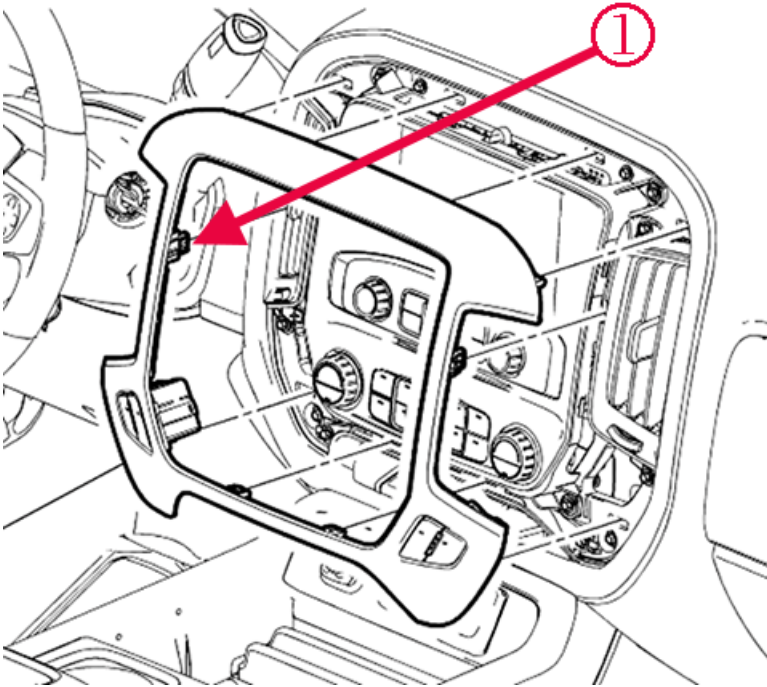
Condition 2: A rattle, squeak or itch type noise from the center of the dash in the radio area.

The instrument panel accessory bezel may be rattling due to insufficient tension of retainers. Press on the bezel while duplicating noise to see if it is eliminated.

Wrap Kent automotive BRS flocking tape part number KT13487 over retainers (#1 in illustration) and reinstall bezel.

This will require an application of BRS flocking tape on ten retainers (one strip @ 1" x 10"). Two sheets should repair 16 vehicles.
