Document ID: IK1201209

Title: SPN 731 FMI 18 Knock Detected: Unexpected Fueling Without Demand

Applies To: 2010+ MF 11/13, 2013+ N13

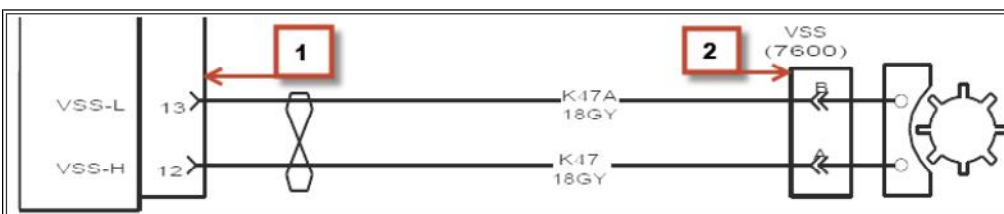
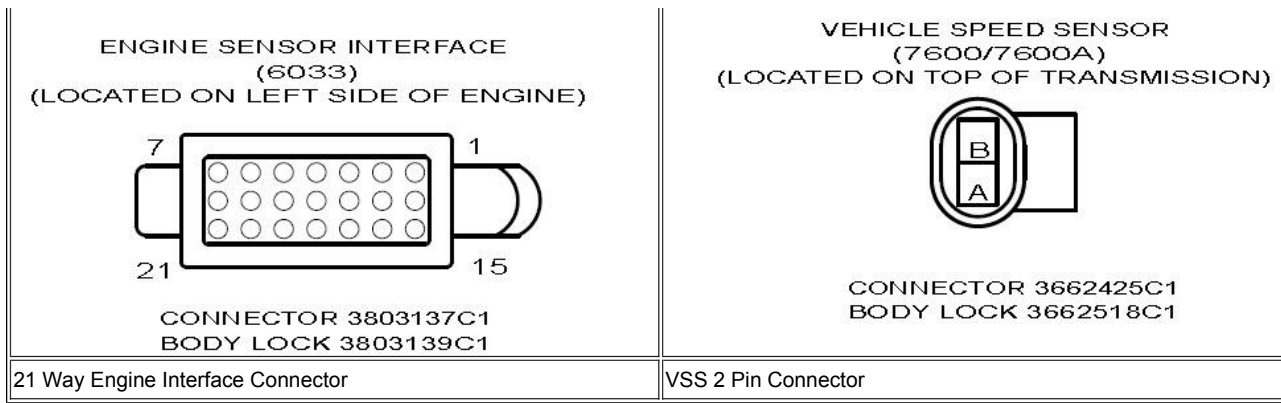
Vehicle Speed Sensor Circuit Rewire

1. (6033) - 21 Way Engine Interface Connector (Location - Left Side of engine behind the ECM)
2. (7600)VSS (Vehicle Speed Sensor) 2 pin Connector (Location - tail shaft of Transmission)

1. Disconnect Vehicles Batteries
2. Install 1 - 3803140C1 and 3803134C1 on the yellow and green wires of 3519281C2 - Bulk Data Link Cable (twisted/shielded).

3. Locate the 21 Way Engine Interface Connector (see schematic above) and disconnect.
4. Remove lock and connector
5. Remove the connector back shell
6. Locate pin cavity 12 and 13.

7. Remove pins cavity 12 and 13.
8. Insert the green wire installed in pin cavity 13 (Pin and Seal should already be installed from previous steps)
9. Insert the yellow wire installed in pin cavity 12 (Pin and Seal should already be installed from previous steps)

10. Route harness to the VSS (Vehicle Speed Sensor) making sure that the harness doesn't contact any sharp objects.
11. Locate pin A and B on the VSS connector

12. Remove the pins from the VSS Connector
13. Install 1 3554322C1 and 3554318C1 on the yellow and green wires 3519281C2 - Bulk Data Link Cable (twisted/shielded).

14. Install the green wire in Pin Cavity B
15. Install the Yellow wire in Pin Cavity A
16. Secure the Harness to ensure it does not have contact with any sharp objects

17. Reinstall the 21 Way Engine Interface Connector
18. Reconnect Vehicles Batteries.
