**Document ID:** IK1900197

**Title:** A/C Compressor Failures and Repair Practices

**Applies To:** All Models

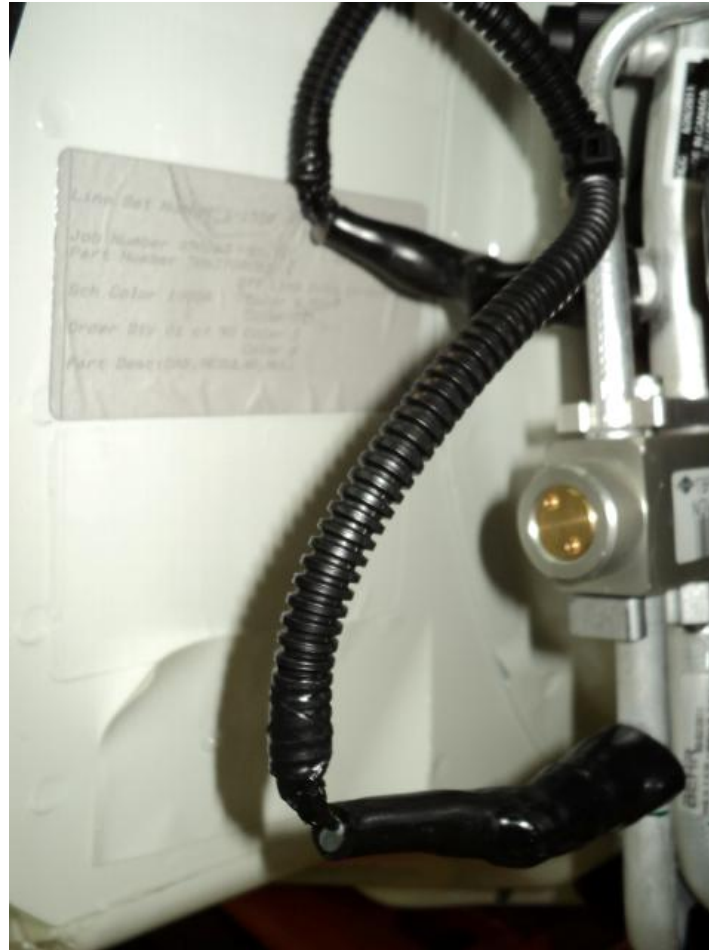
5. The thermistors should also be inspected for the correct installation of the heat shrink. The heat shrink on the opposite side of the thermistor should not be installed OVER the convoluted tape. The picture below shows the correct way to install the heat shrink.
