<b>Countries:</b>	CANADA, UNITED STATES	<b>Document ID:</b>	IK0700082
<b>Availability:</b>	ISIS, FleetISIS	<b>Revision:</b>	4
<b>Major System:</b>	EXHAUST	<b>Created:</b>	1/9/2015
<b>Current Language:</b>	English	<b>Last Modified:</b>	4/26/2016
<b>Other Languages:</b>	NONE	<b>Author:</b>	Keith Kierzek
<b>Viewed:</b>	2692

**Title: N9/N10/N13 Aftertreatment Fault Codes Caused by Incorrect DPF Differential Pressure Sensor Orientation**

**Applies To: All Navistar Powered SCR Vehicles**

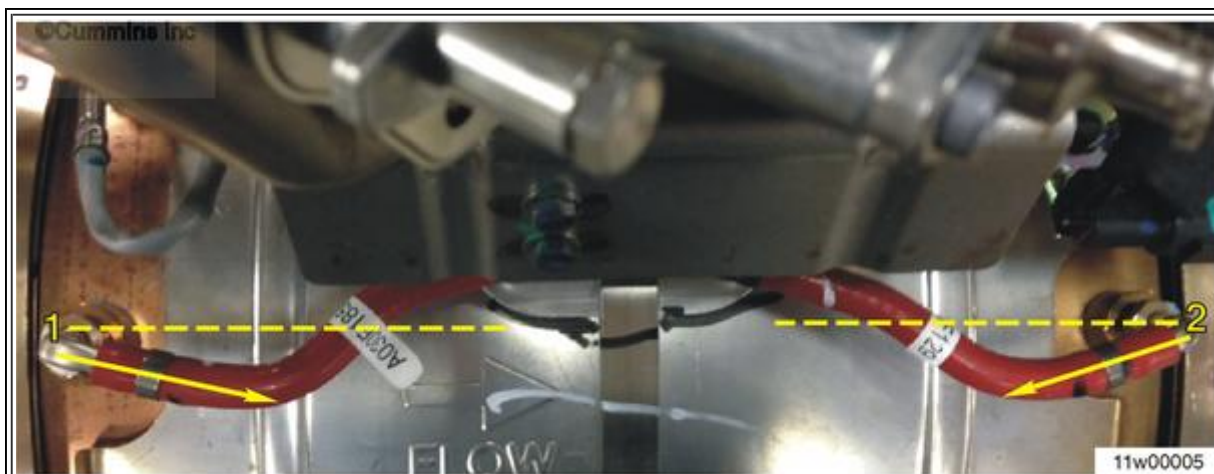
The aftertreatment DPF differential pressure sensor can be installed in an incorrect orientation (**Figure 1**). This orientation of the sensor allows moisture to be trapped inside the sensor and/or sensor tubes. The trapped moisture affects the signal processing of the sensor when reading the pressure inside the DPF, leads to incorrect pressure readings, and Fault Code(s) 3251-2, 3251-16, 3251-0, 3936-15, 3251-15, 3610-2, and 3936-16 being set.

**Figure 1: Incorrect DPF differential pressure sensor orientation**

The DPF differential pressure sensor tubes should have a 0-10 degree downward slope away from the sensor ports whether in a vertical or horizontal aftertreatment configuration. A 0-10 degree sensor tube downward angle is recommended to make sure that no cavity exists in the tubes to collect moisture.

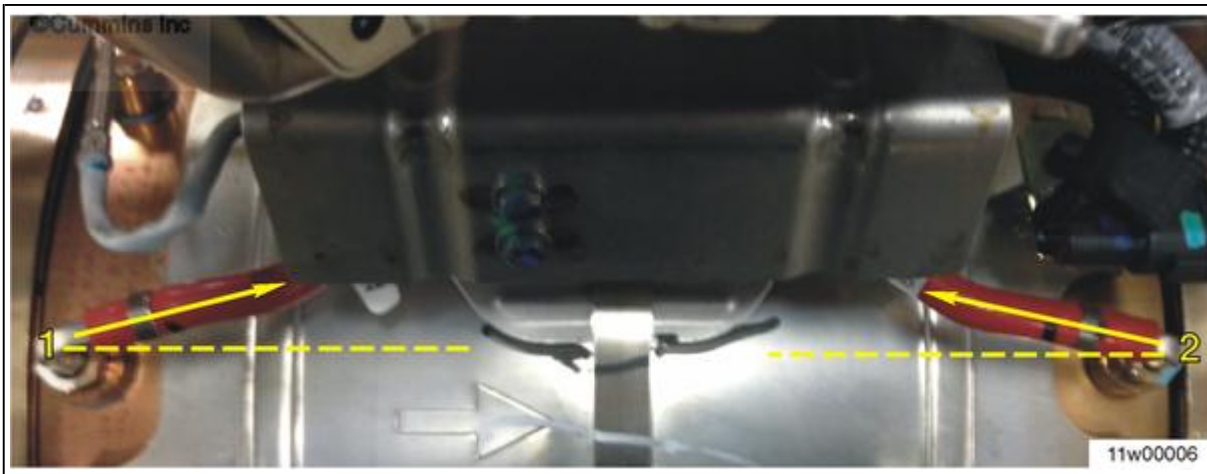
Step	Action	Decision
2	<p><b>VISUAL INSPECTION:</b></p> <p>Visually inspect the aftertreatment DPF differential pressure sensor to confirm its orientation. 0 to 10 degrees is acceptable (<b>Figure 2</b>). Any amount of droop below 0 degrees is not acceptable (<b>Figure 3</b>).</p> <p><b>Is the DPF differential pressure sensor installed in the correct orientation?</b></p> <div style="border: 1px solid black; padding: 5px; margin-top: 10px;"> <p><b>NOTE:</b> 0 degrees is acceptable</p> </div>	<p><b>Yes:</b> Return to appropriate Fault Code Action Plan (FCAP) to continue troubleshooting fault codes.</p>
		<p><b>No:</b> Follow the steps below in the <i>Repair Steps</i> section and retest for active fault codes. Do NOT install a new DPF differential pressure sensor.</p>

**Figure 2: Correct Orientation - Between 0 and 10 degrees**

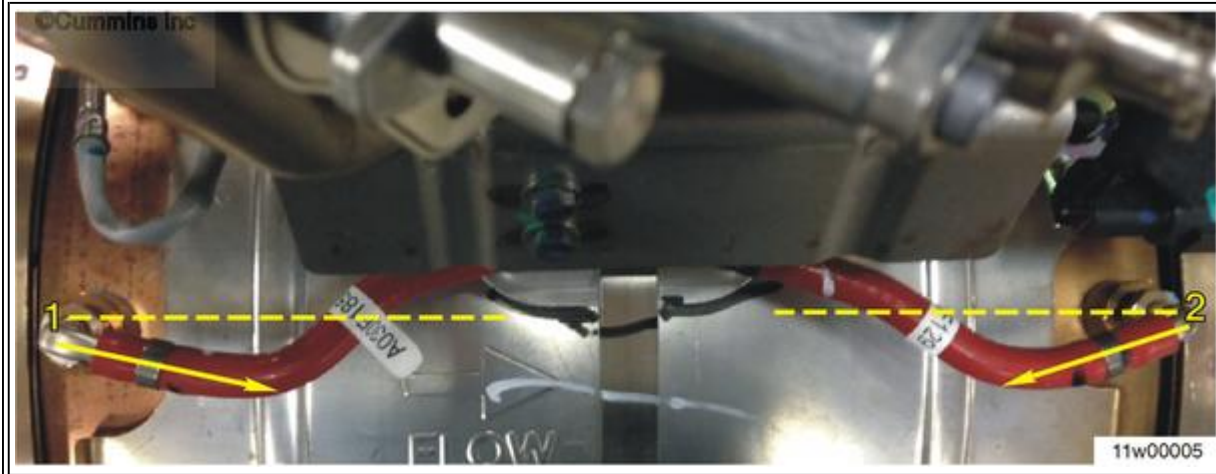
**Figure 3: Incorrect Orientation - Below 0 degrees**

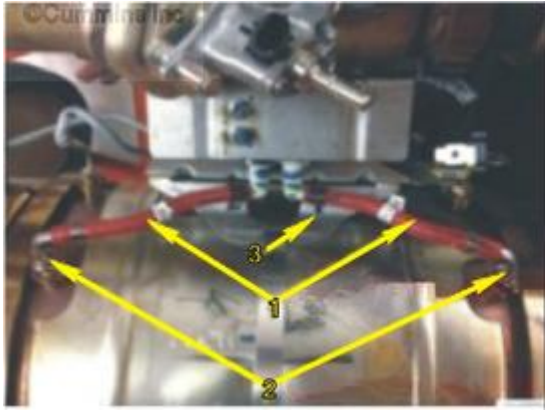
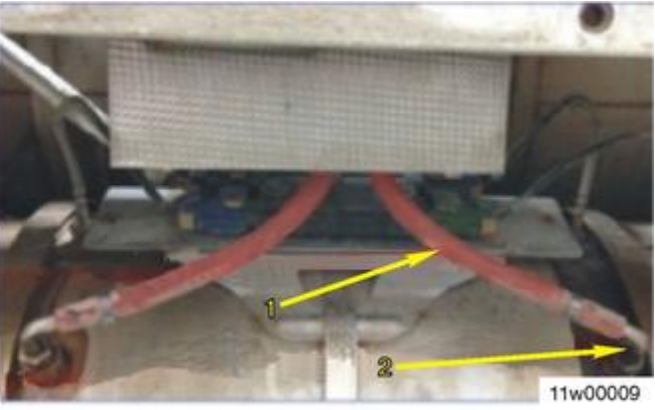
<b>Figure 4: Canister mounted (left) versus remote mounted (right) DPFDP sensor</b>

Item 1: DPF DP Tubes Item 2: DPF DP Sensor Port Fittings Item 3: DPF DP Tube P-Clips	Item 1: DPF DP Tubes Item 2: DPF DP Sensor Port Fittings

4. Tighten the aftertreatment DPF differential pressure sensor mounting bracket strap to 7 N•m [5 ft-lb].
5. Adjust the DPF Differential pressure sensor port fittings to match the 0-10 degree downward angle (Figure 4). Tighten the upstream DPF differential pressure sensor port fitting after adjustment to 31 N•m [23 ft-lb]. Tighten the downstream DPF differential pressure sensor port fitting after adjustment to 17 N•m [13 ft-lb].

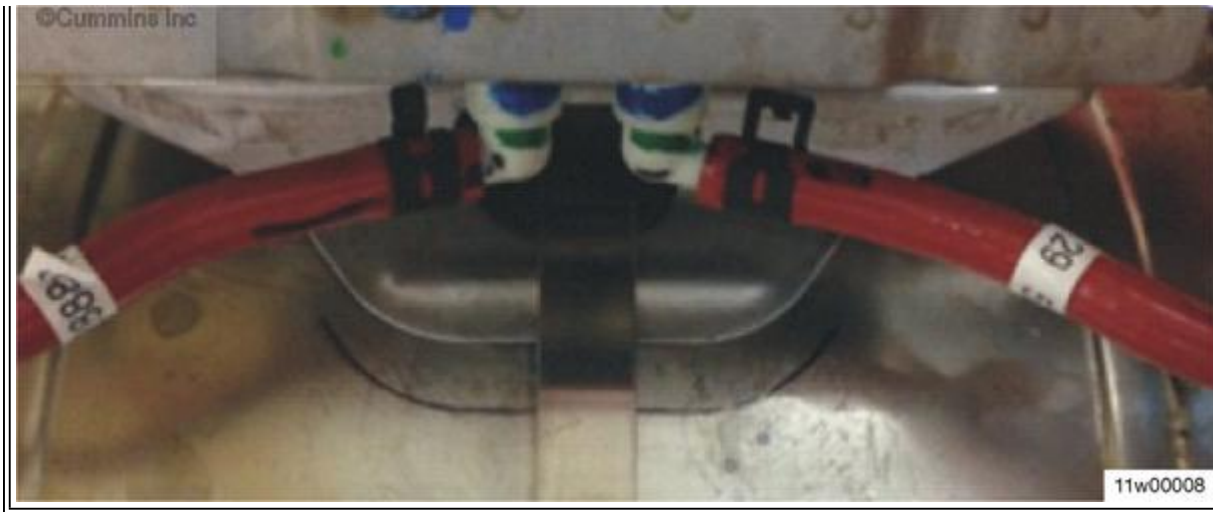
<b>Figure 5: DPF differential pressure sensor orientation with marking from previous incorrect orientation</b>

1. Loosen the DPF differential pressure sensor mounting bracket strap and allow the DPF differential pressure sensor tubes to locate the aftertreatment DPF differential pressure sensor bracket on the aftertreatment DPF Canister.
2. Mark the location of the DPF differential pressure sensor bracket on the aftertreatment DPF canister by pressing the DPF differential pressure sensor bracket against the DPF canister and tracing along the bottom of the DPF differential pressure sensor bracket (**Figure 5**).

3. Rotate the DPF differential pressure sensor bracket by moving it toward the top of the DPF canister to achieve a 0-10 degree sensor tube downward angle. Do **not** move the sensor mounting bracket more than 19 mm [3/4 in] above the reference mark.
