**Document ID:** IK1201258

**Title: Catastrophic DOC and DPF Failures**

**Applies To: All Navistar Engines**

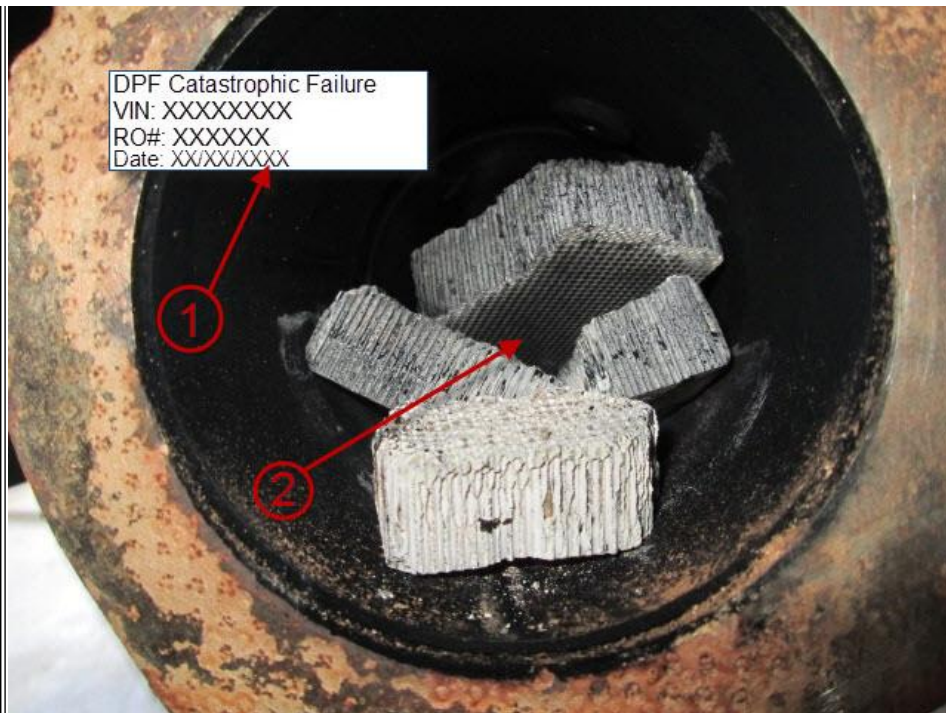
**Figure 2: DPF Substrate separation**

Item 1: Unit details (Do not block the damage with the tag).  
Item 2: Clear image of the damage.

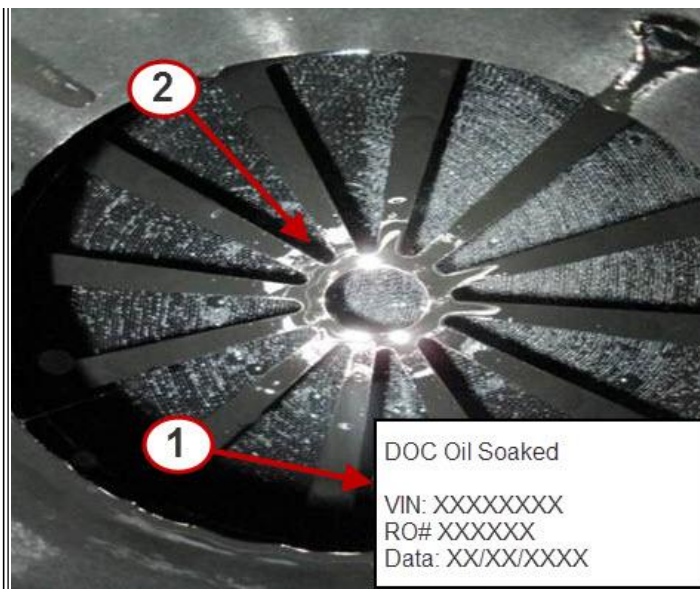
**Figure 6: Oil Soaked DOC**

Item 1: Unit details (Do not block the damage with the tag).  
Item 2: Clear image of the damage.

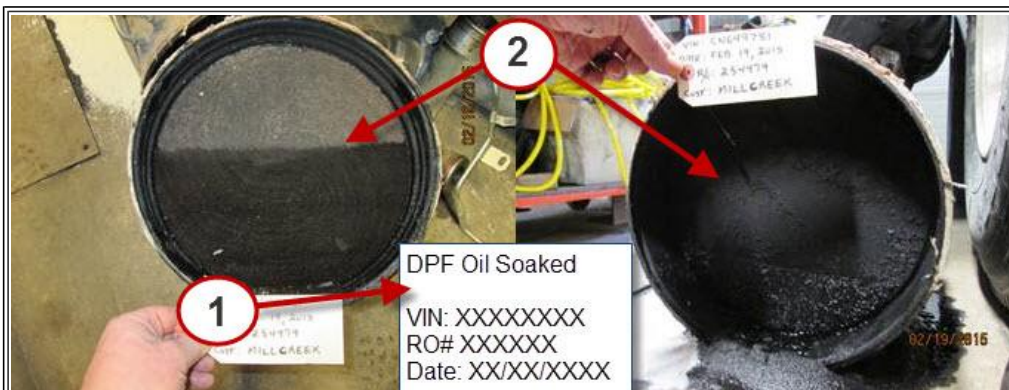
**Figure 7: Oil Soaked DPF**

Item 1: Unit details (Do not block the damage with the tag).  
Item 2: Clear image of the damage.

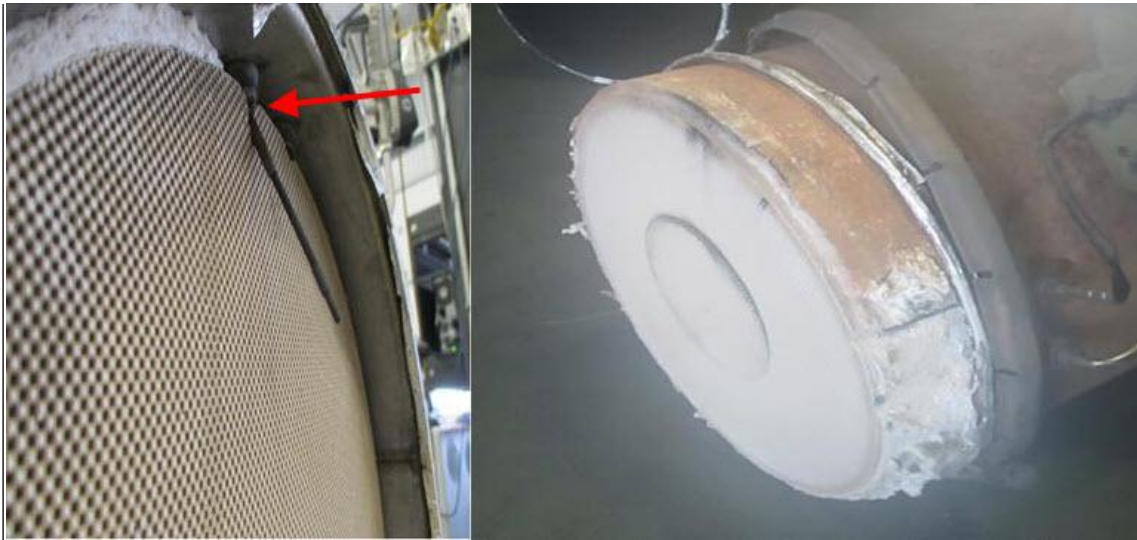
**Figure 8: Excessive substrate shifting**

**Moderate substrate shifting is not considered a catastrophic failure.** Excessive shifting is defined as enough movement to damage sensors. Please reference the aftertreatment diagnostic manual for additional information on brick shifting.

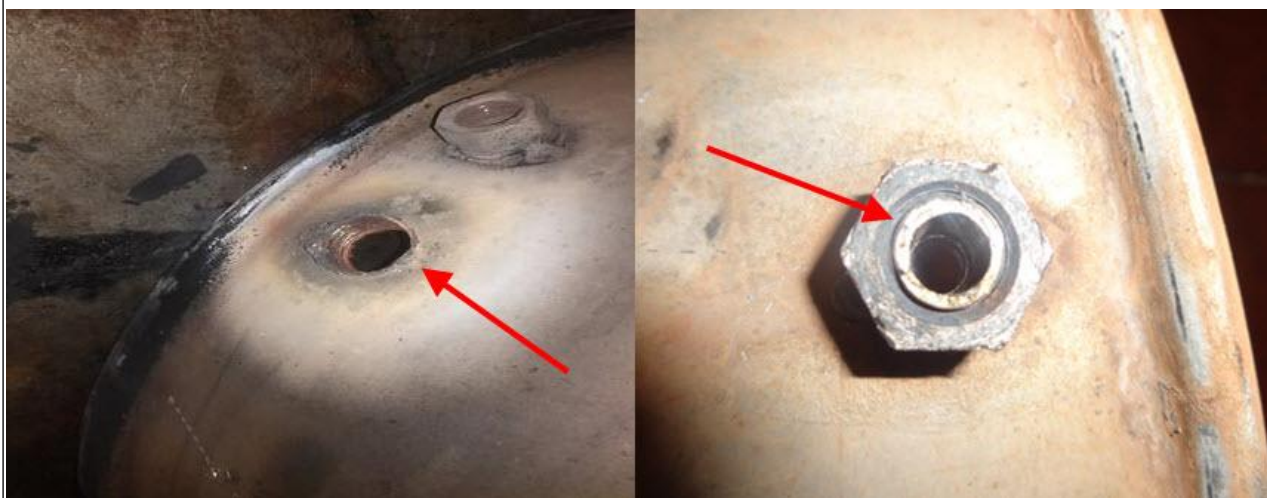
**Figure 9: Broken bung**

Pictured above are broken bungs. If broken or damaged unable to remove DPFDP tube the assembly must be replaced. **Stripped threads are not considered a catastrophic failure.** Reference the aftertreatment diagnostic manual (P.225) for repair process.

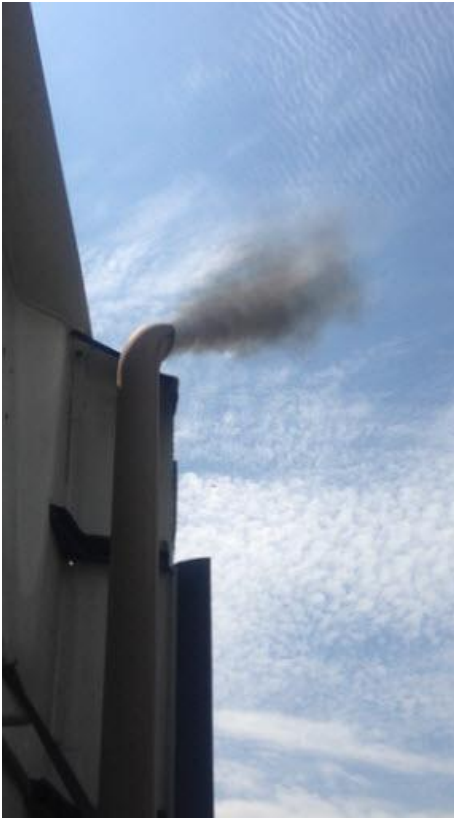
**Figure 10: Black smoke**

If continuous black smoke is seen exiting the tailpipe during one of the following tests below then the DPF has catastrophically failed.

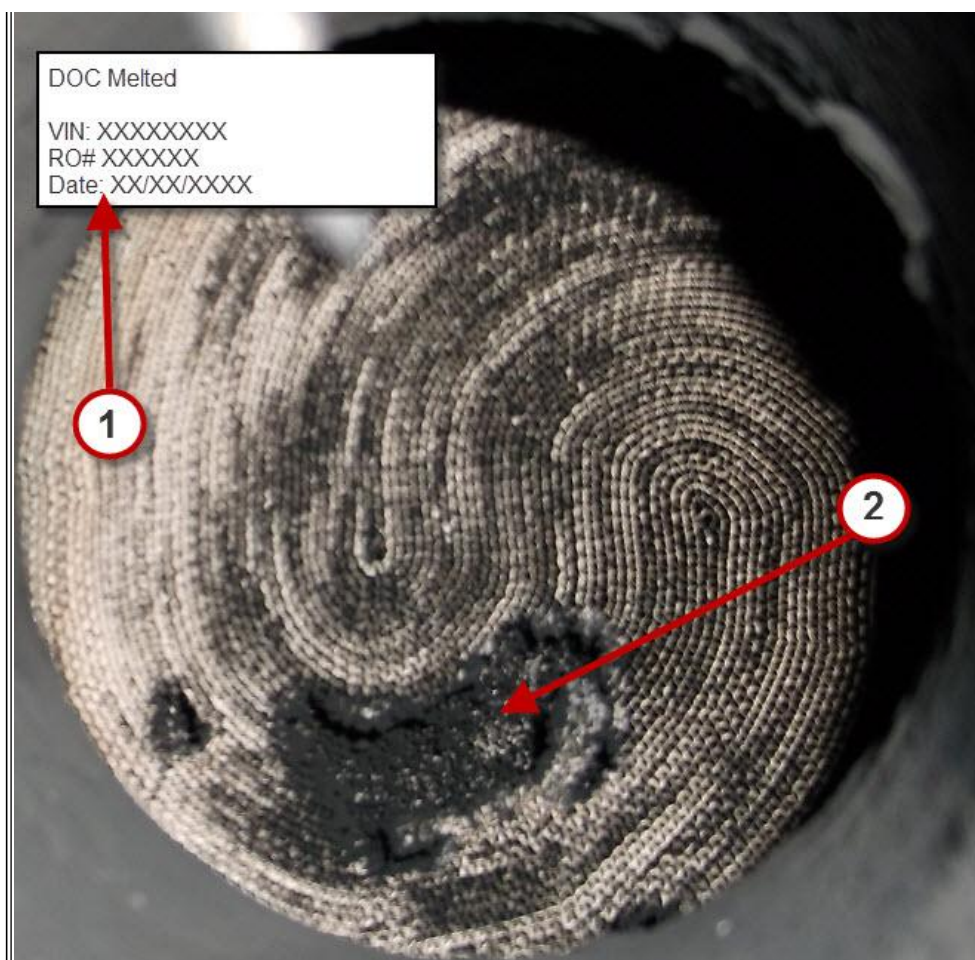
**Figure 11: Melted DOC**

Item 1: Unit details (Do not block the damage with the tag).

Item 2: Clear image of the damage.

Description: Followed Aftertreatment Diagnostic Manual 0000003081 symptom 3 to step 4, identified DOC was melted. Replaced DOC, followed to step 6 to verify system operation found unit has a cracked injector tip that is the root cause of the DOC melting. Completed all repairs and verified unit meets all operating specifications listed in the engine diagnostic manual.

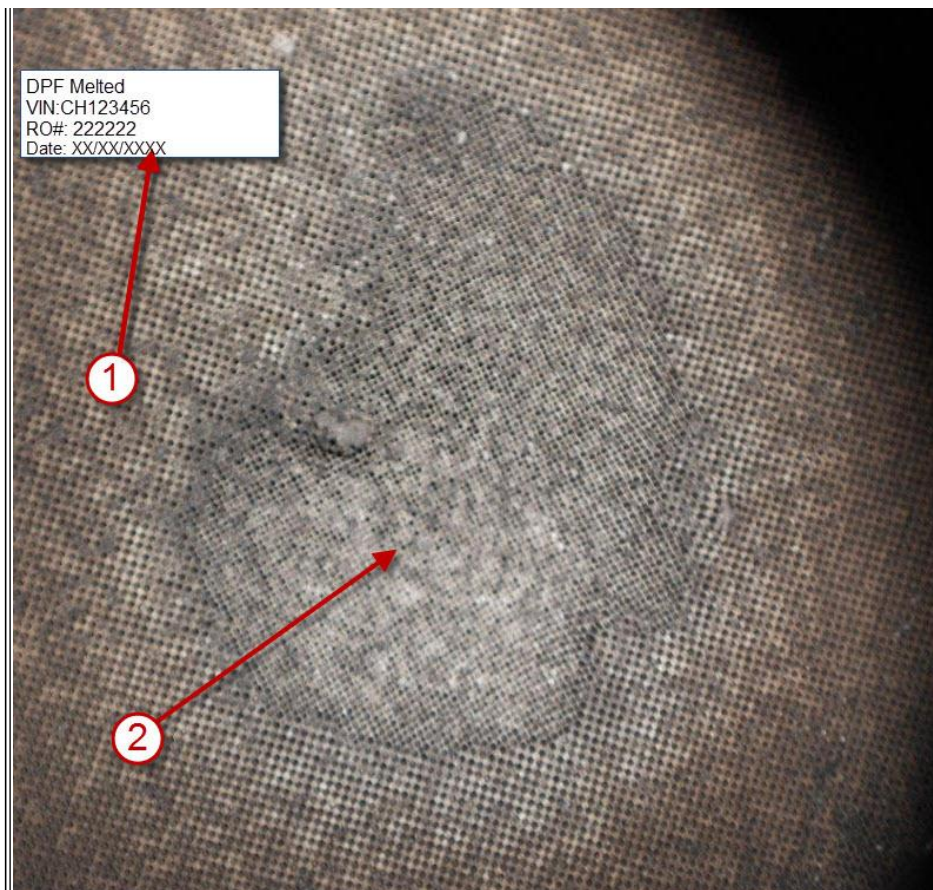
**Figure 12: Melted DPF**

Item 1: Unit details (Do not block the damage with the tag).  
Item 2: Clear image of the damage.

*Description:* Followed Aftertreatment Diagnostic Manual 0000003081 symptom 5 to step 2, identified DPF was melted. Replaced DPF, followed to step 4 to verify system operation found unit has a cracked injector tip that is the root cause of the DPF melting. Completed all repairs and verified unit meets all operating specifications listed in the engine diagnostic manual.
