Title: High-pressure turbocharger outlet blockage

Applies To: 2015 Model N13 Engines

DESCRIPTION

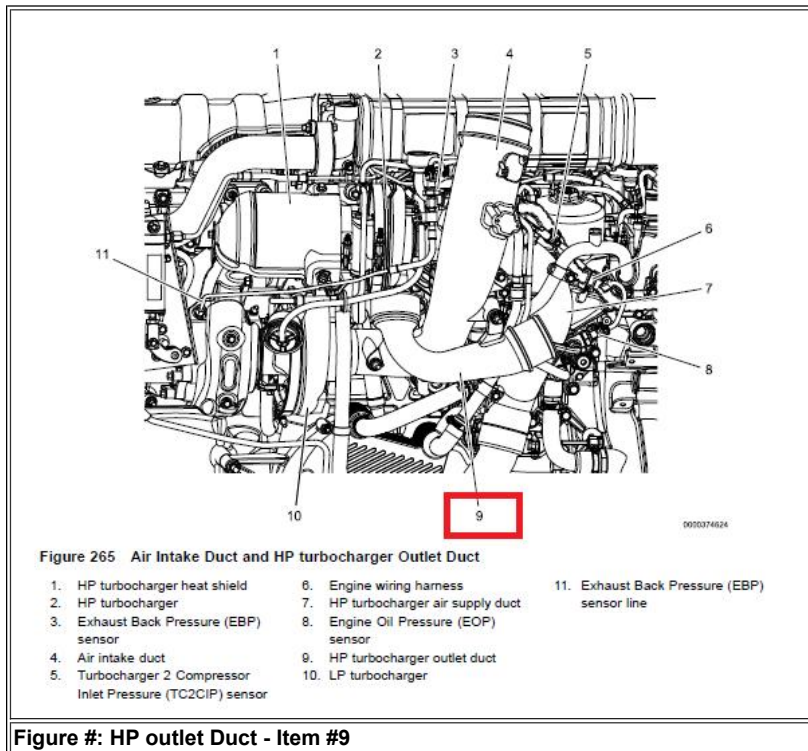
Step	Action	Decision
1	<p>Visually inspect the air intake system. Check for Blockage in the High-pressure turbocharger outlet duct. (This step is directly related to step 2 of the diagnostics in the manual for this code. This article simply expounds upon this step to check the air intake piping.) (see figures below for examples of blockage)</p> <p>Is there blockage present?</p>	<p>Yes. Replace High-pressure turbocharger outlet duct, and retest.</p>
		<p>No. Continue diagnostics through FCAP.</p>

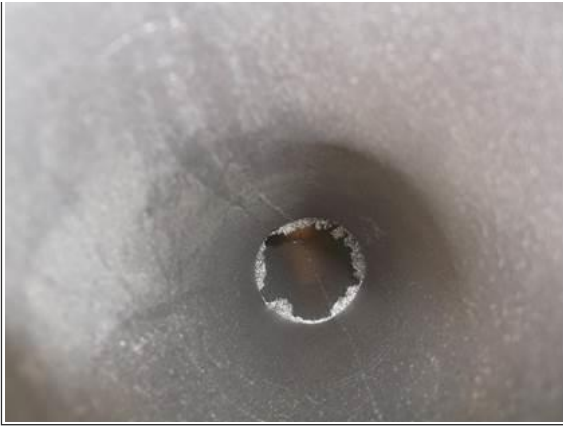
This document should be used in conjunction with the FCAPS: fault codes 102-10 and 102-18. And will guide the user through identifying low boost condition caused by a casting defect in the HP turbocharger outlet pipe.

Figure #: Blockage

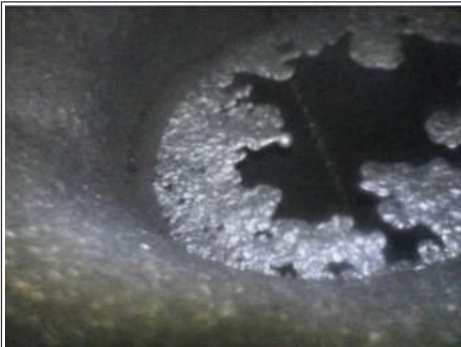
Figure #: Blockage
