**Document ID:** IK1600207  
**Revision:** 2  
**Created:** 6/5/2014  
**Last Modified:** 6/6/2016  
**Author:** David Smith

**Title:** Wind noise at upper side door

**Applies To:** All steel cabs: ProStar, LoneStar, TranStar, WorkStar, DuraStar, TerraStar

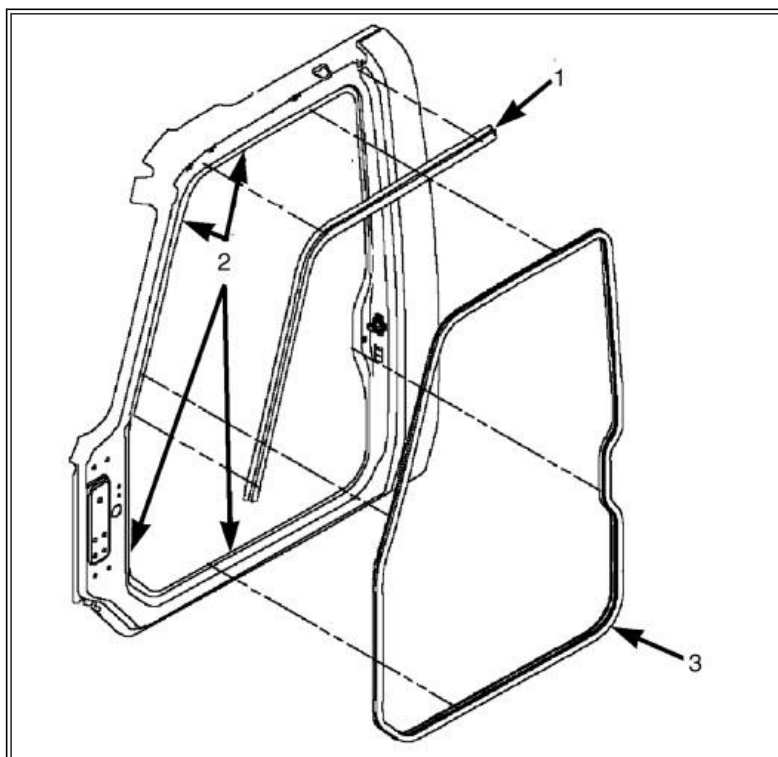
**Figure 1: Door Seals**

There are instances when the cab side entry door does not have proper contact with the door seals along the top of the door causing wind noise and/or flutter. In extreme cases and in inclement weather, there could be water intrusion as well. Many design improvements were made between 2004 and 2009 that drastically improved quality in this area, however there are still isolated occurrences when this issue still persists.

1. Inspect the primary (Figure 1, Item 3) and secondary (Figure 1, Item 1) door seals. Ensure they are seated down completely. If there is any visible damage or waves, adjust or replace as necessary.

3. After replacing or adjusting any of the parts in steps 1 or 2, remove the primary door seal (Figure 1, Item 3).
4. While closing the door, place a dollar bill or similar size/shape piece of paper between the secondary door seal (Figure 1, Item 1) and the door (Not Shown) at the base of the A-pillar where the secondary door seal starts/terminates just above the upper door hinge (Figure 2, Item 1).

5. Slide the dollar bill up and along the door all the way back to the upper rear corner of the door.
6. If the dollar bill does not slide freely, there is proper contact between the door and seal and no shimming is required. Reinstall the primary door seal (Figure 1, Item 3), ensuring that it is completely seated all the way around the door perimeter. The job is complete.
