**Document ID:** IK0900115

**Title:** Fan Shaft Failure Diagnostics

**Applies To:** 11/13L ProStar, PayStar, and TransStar with feature code 12THX (Viscous Fan Drive)

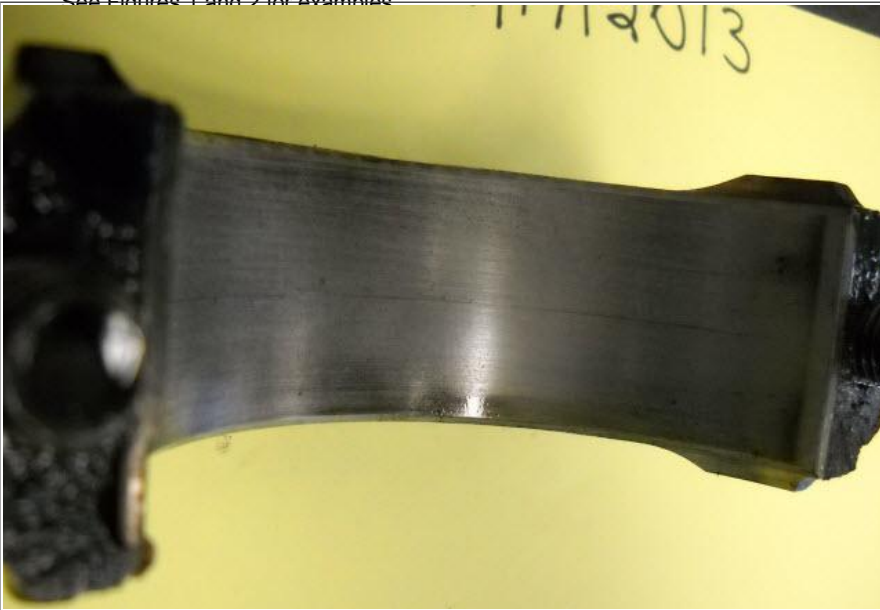
**Figure 1: Good bearing - reusable**

**Yes.** Replace all cap bolts, then proceed to Step 2.

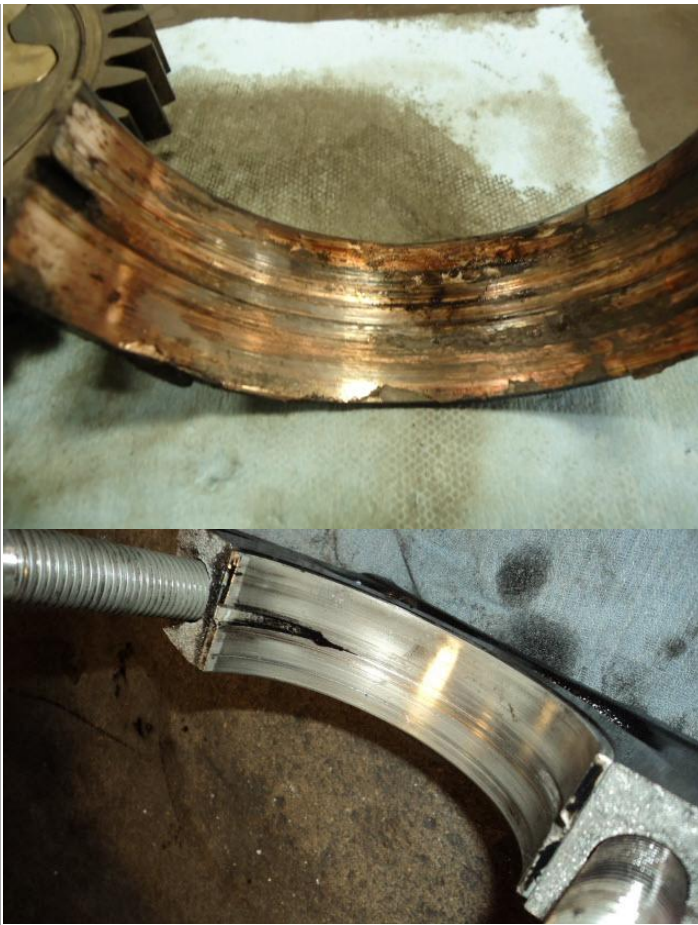
**Figure 2: Unusable Bearings**

**No, bearings do not meet reuse guideline but journals are free from defects.** Replace compromised bearings and all cap bolts, then proceed to Step 2.

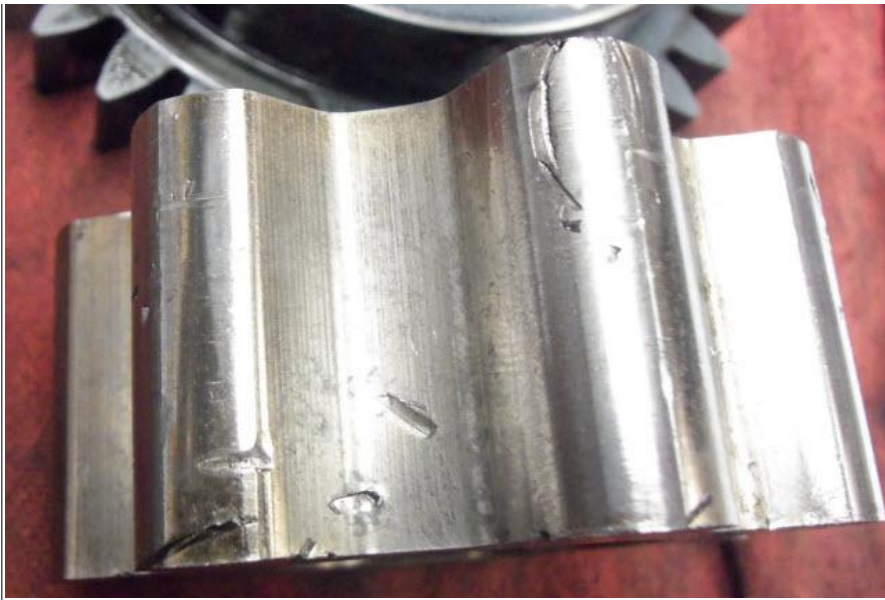
Figure 3: Damaged oil pump/gerotor

Step	Action	Decision
3	<b>OIL PUMP GEROTOR REUSE OR REPLACE DETERMINATION:</b>	<b>Yes.</b> Replace gerotor, proceed to Step 4.
	Inspect oil pump gerotor. See Figures 3 and 4 for examples of damage.	
	<p><b>NOTE:</b> there may be some light scoring on the block behind the oil pump as pictured in Figure 5. This amount is acceptable and will not lead to loss of oil pressure or engine performance/longevity as long as gear end play is in spec.</p> <p>End play between the oil pump cover and oil pump gears must be measured while inspecting the oil pump. This procedure is outlined in the Engine Service Manual found on the <a href="#">Master Service Information Site</a>. If end play exceeds specification, replace oil pump cover, pinion (gear) for oil pump, and ring gear as a set.</p> <p>Is the gerotor damaged?</p>	<b>No.</b> Proceed to Step 4.

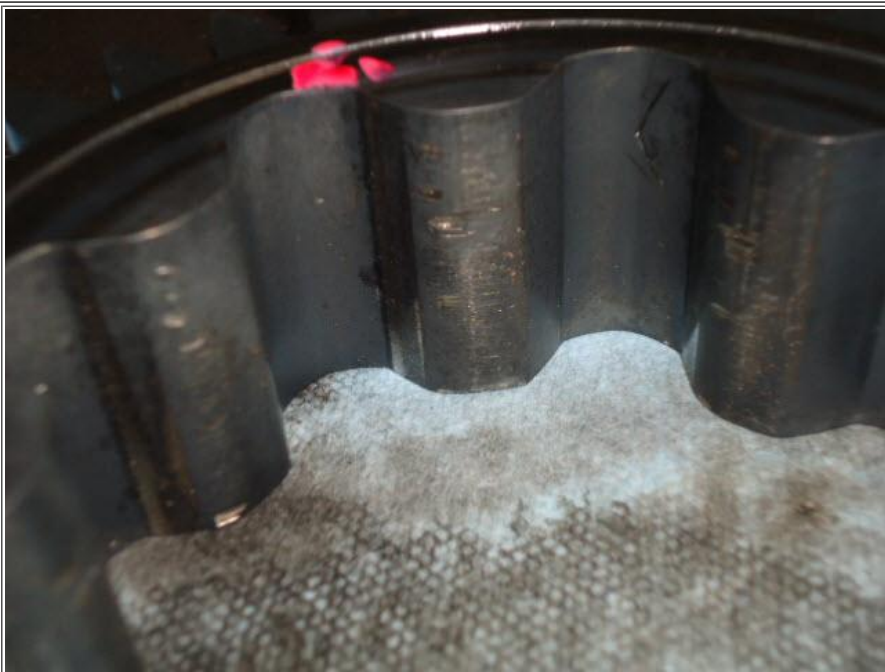
Figure 4: Damaged oil pump/gerotor

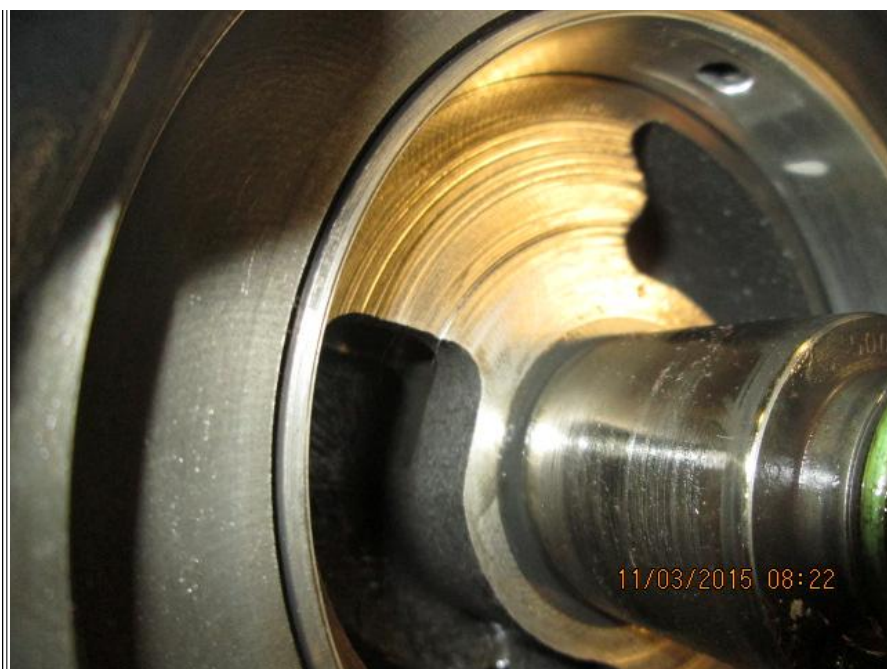
Figure 5: Acceptable engine block wear behind oil pump

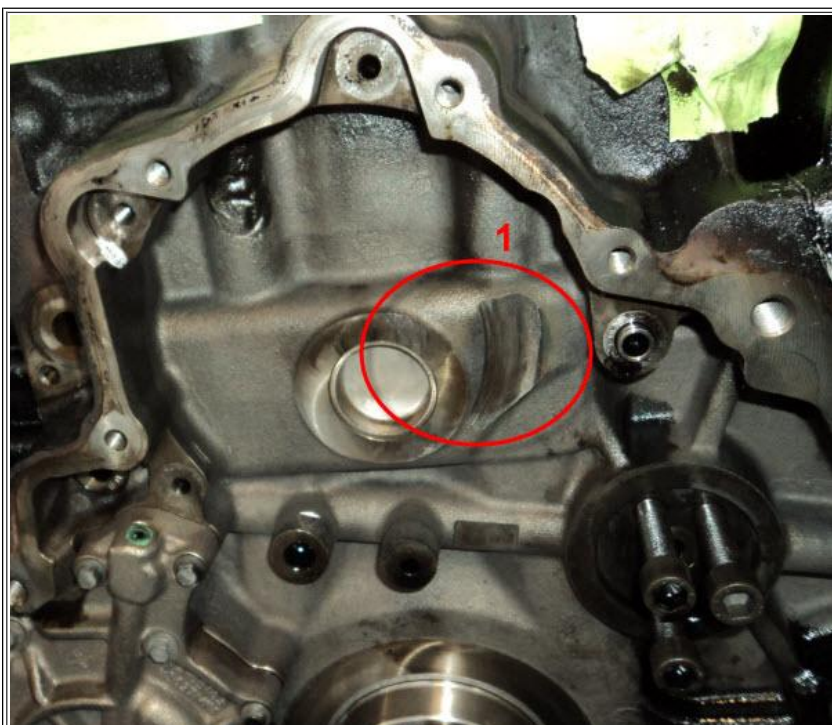
Figure 6: Acceptable engine block wear

Item 1: Gear contact to the engine block

Step	Action	Decision
4	<b>FRONT GEAR TRAIN INSPECTION:</b>	<b>Yes.</b> Replace damaged gears.
	While the front cover is off, inspect remaining gears for damage.	
	<b>NOTE:</b> It is possible that gear contact to the engine block has occurred. These engine blocks should be reused, and will not lose performance/longevity. See Figures 6 and 7 for examples.  Are there any other gears damaged?	<b>No.</b> Proceed to Step 5.

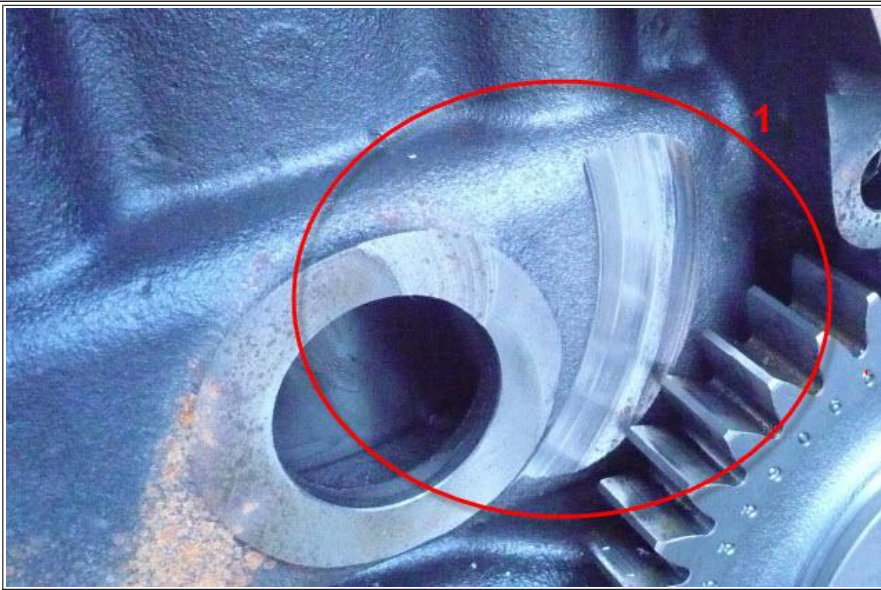
**Figure 7: Acceptable engine block wear**

Item 1: Gear contact to the engine block

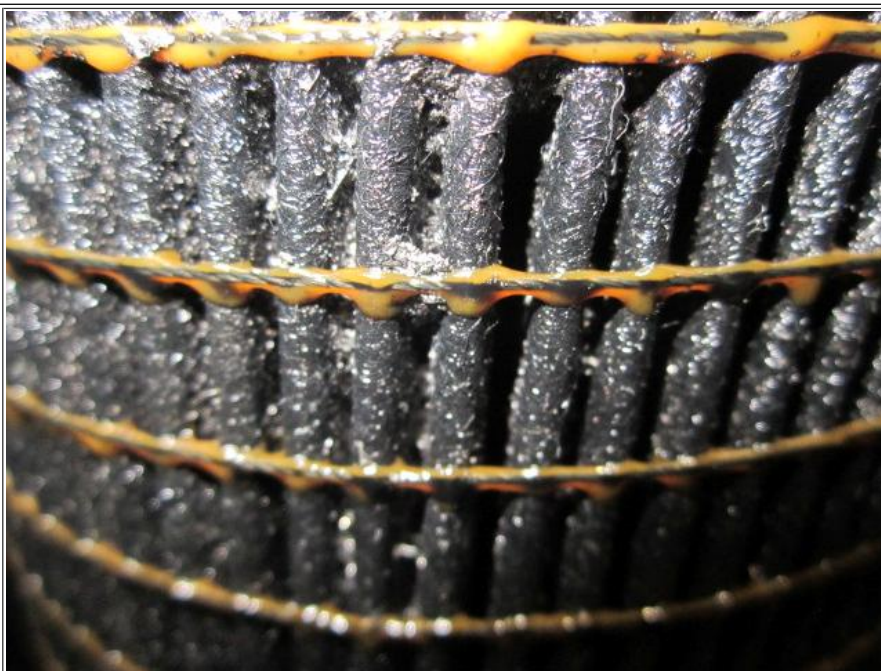
**Figure 8: Oil filter with metal shavings present**

Step	Action	Decision
5	<b>OIL COOLER REPLACE OR REUSE DETERMINATION</b>	
	Inspect oil filter.	<b>Yes.</b> Replace oil cooler, centrifuge, oil, and oil filter then proceed to Step 6.
	Are there metal shavings in the oil filter? See Figure 8 for an example.	<b>No.</b> Replace centrifuge, oil, and oil filter, then proceed to Step 6.
