**Countries:** CANADA, UNITED STATES **Document ID:** IK2600230  
**Availability:** ISIS, Bus ISIS, FleetISIS, IsSIR **Revision:** 7  
**Major System:** PROGRAMMING SUPPORT **Created:** 9/29/2016  
**Current Language:** English **Last Modified:** 11/29/2016  
**Other Languages:** NONE **Author:** Kendall Prohett  
**Viewed:** 2138

**Title:** OnCommand™ Link Essential Update**Applies To:** OnCommand Link

This document will inform the user of an essential update made to the OnCommand Link device, used for Over The Air Programming. This essential update addresses issues regarding false DTCs and/or flashing lights on the Instrument Cluster.

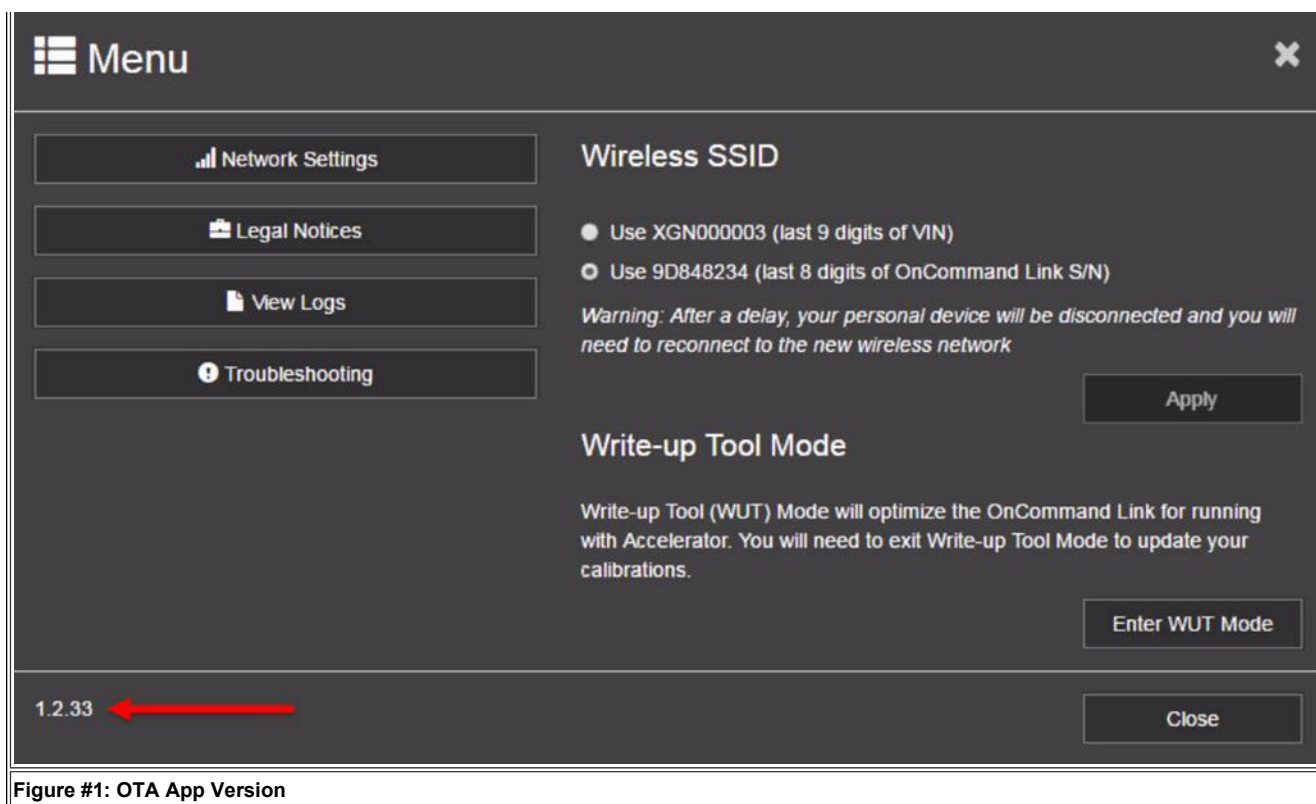
Figure #1: OTA App Version

To alleviate this issue, there has been a release of firmware and application updates. Ensure that the software on your OnCommand Link device is updated by checking the menu, or looking at the right-hand side of the Health Report (Figure 2) uploaded to the Service Portal. When connected to the OnCommand Link webpage, click on the Menu on the upper left-hand side. The software version will be listed on in left-hand corner. If your software version is not **AT LEAST** 1.2.33 (Figure 1) or higher, it will need to be updated.

6. Wait **at least** 30 minutes before attempting to reconnect; it may take up to 1 hour.
7. Reconnect to Link SSID from your personal device.
8. Open your web browser and go to <http://192.168.100.1/navistar> and check the version listed under the MENU button is listed **AT LEAST** 1.2.33 (Figure 1) or higher.
