SP 3-284-002
SERVICE PROGRAM

January, 2016

Transmission Control Module (TCM) Shield.

This Service Program provides information regarding the installation of the Transmission Control Module (TCM) shield on certain model year 2014-2015 Xpeditor vehicles with Cummins ISX engines.

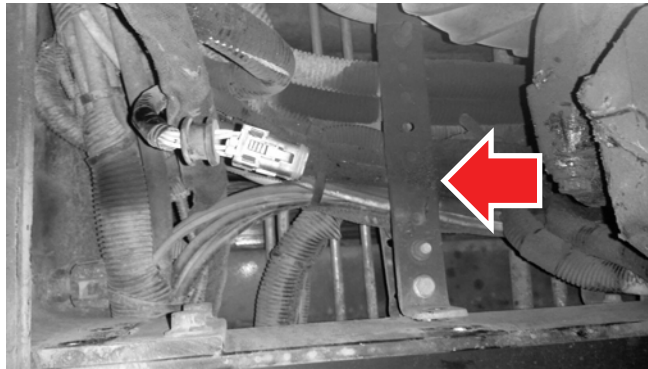
Figure 4, L-Bracket

Note: The L-bracket must be removed because the new TCM shield is 2 inches higher than the top of the cross member when mounted.

7. Remove the L-bracket that is mounted flush with the top of the cross member and set aside for reinstallation (see Figure 4).
