# NEWMAR CORPORATION WARRANTY DEPARTMENT

## RECALL SERVICE BULLETIN

| DATE ISSUED | MODEL YEAR(S) AFFECTED | RSB # |
|---|---|---|
| 12/15/2016 | 2017 | 473 |

## How to Replace the Accent Light Module

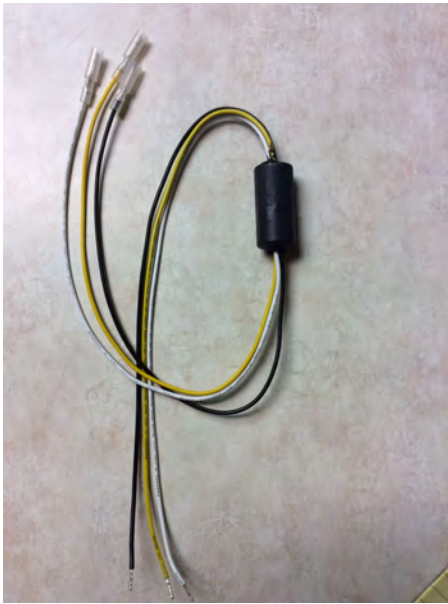
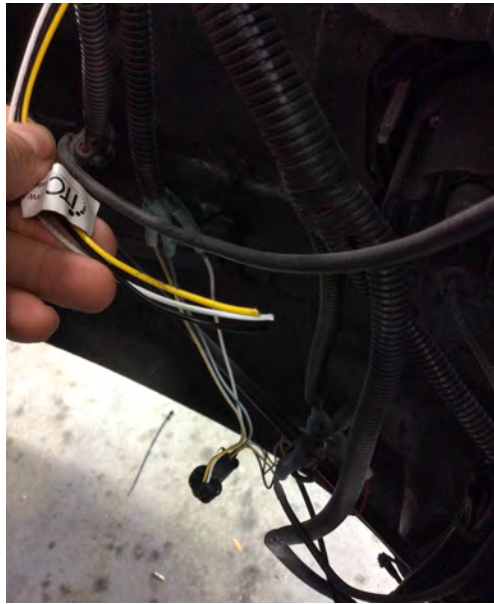
## Inspecting the New Module

The new sealed light module will have stripped wire leads on one side, which will connect to the coach wiring. The other side will have connectors on them. It is important to correctly install the module due to a diode that was added.

1. Locate the three wires connecting the accent light to the light module.
2. Cut the connection from the light module, and strip the three wires back.
3. On the new module, find the side with terminals. This will hook up to the light, so do not reverse them.

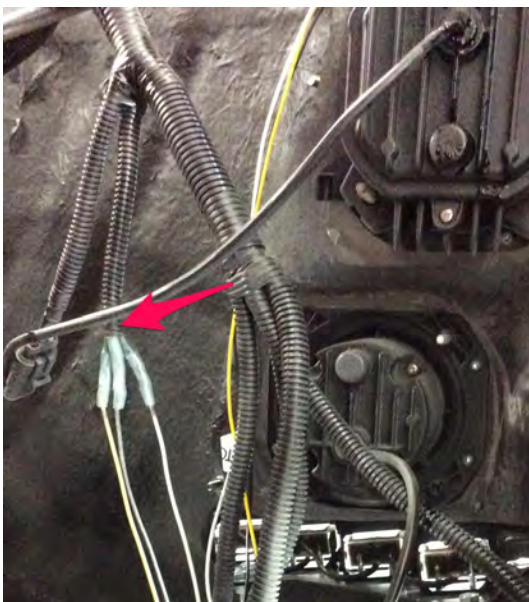
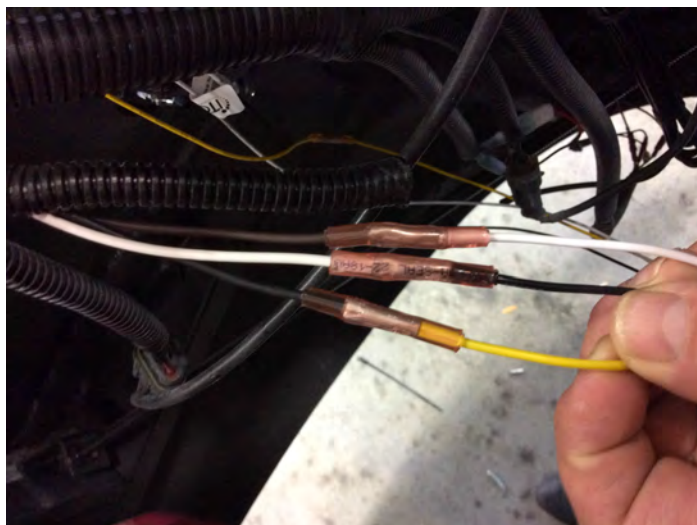
## Connecting the New Module to the Coach Harness

The wire colors do not match up.

7. From the harness side of the module, cut off the old connectors.
8. Pull back the black wire loom if necessary.
9. Strip back the wires.
10. Hook up the wires as shown.

- Harness black = Module yellow
  - Harness white = Module black
  - Harness brown = Module white
11. Heat and seal the butt connectors.
