# NEWMAR CORPORATION WARRANTY DEPARTMENT

## RECALL SERVICE BULLETIN

DATE ISSUED	MODEL YEAR(S) AFFECTED	RSB #
12/01/2016	2017	474

Spartan Motors USA, Inc. has decided that a defect relating to motor vehicle safety exists in specific motor homes built on Spartan chassis. In response, Newmar Corporation is publishing a recall:  
NHTSA #16V 810 TC #2016-543.

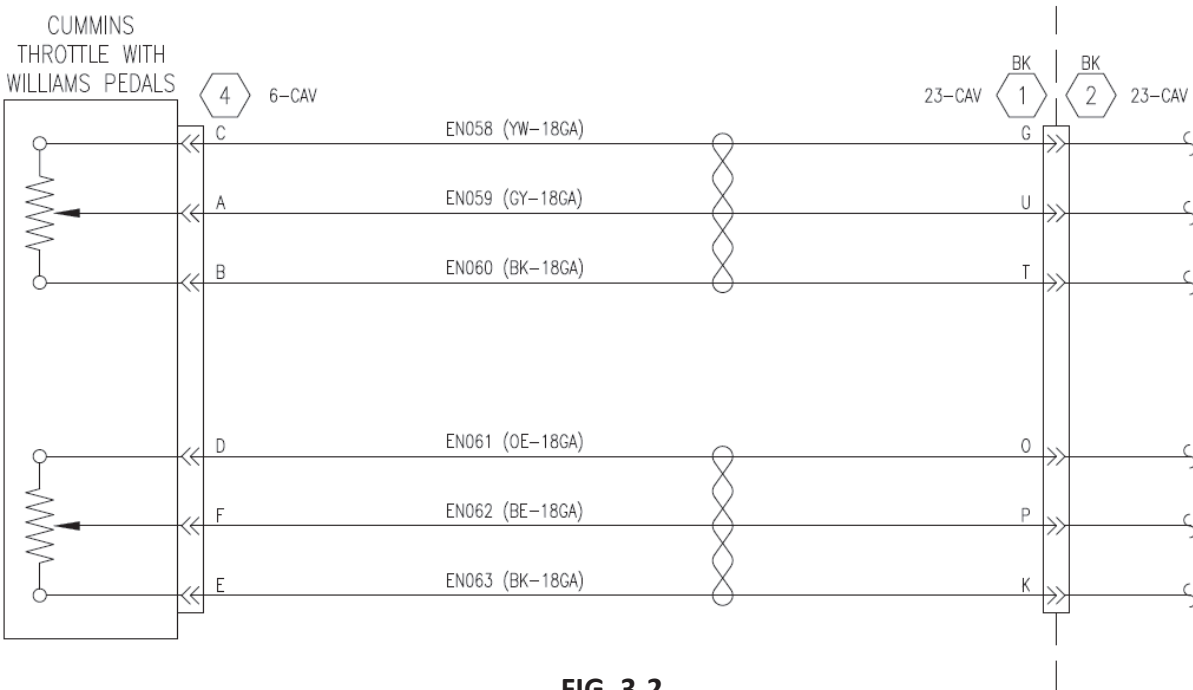
**FIG. 3-2**

1. Identify and disconnect throttle pedal connector, Item ④ in FIG. 3-2, from throttle assembly. Pull back loom 12 inches over wiring terminated into throttle pedal connector. Verify wiring consists of 6 discreet wires (untwisted) then go to step 2. If wiring consists of 2 twisted triplets (refer to FIG. 3-2), replace loom over wiring and reconnect throttle pedal connector, Item ④. No further action is required.

2. Pull back existing throttle pedal connector and stow/tape it back onto existing harness.
3. Connect new throttle pedal connector, Item ④, of new 3995-GG5-001 overlay harness into throttle assembly. Refer to FIG. 3-2.

5. Locate and disconnect main chassis harness interconnect, Item ①, from forward electrical compartment disconnect. Refer to FIG. 3-2
6. Using Deutsch contact removal tool, remove circuits from disconnected Item ①, cavities O, P, K, G, U, and T. Refer to FIG. 3-1.

- Cut off contacts from removed circuits, individually heat shrink, and pull/tape back onto existing harness.
- Insert new circuits from new overlay harness into existing main chassis harness interconnect connector Item 1. Refer to FIG. 3-1. Each wire is tagged with a label depicting which cavity it belongs in. Refer to FIG. 3-2. Note that the wiring/pin out does not change.

, to firewall disconnect. Refer to FIG. 3-2.
10. Assure new overlay harness is secured to existing harness as required throughout its entire run. Tape back any extra length as required.
11. Using Cummins® INSITE™, verify that no fault codes are generated at key-up. Also verify that appropriate values are seen in regards to throttle pedal position.

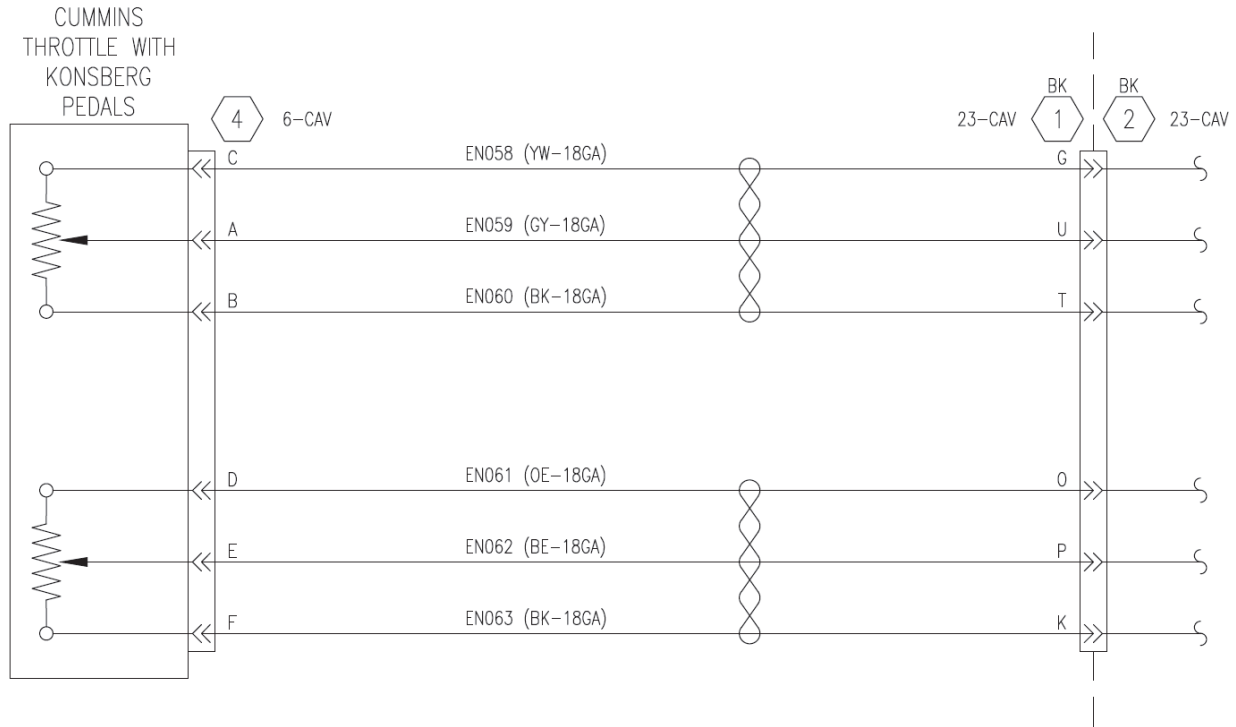
**FIG. 6-1**

1. Identify and disconnect throttle pedal connector, Item **④** in FIG 6-1, from throttle assembly. Pull back loom 12 inches over wiring terminated into throttle pedal connector. Verify wiring consists of 6 discreet wires (untwisted) then go to step 2. If wiring consists of 2 twisted triplets (refer to FIG. 6-1), replace loom over wiring and reconnect throttle pedal connector, Item **④**. No further action is required.

2. Pull back existing throttle pedal connector and stow/tape it back onto existing harness.
3. Connect new throttle pedal connector, Item **④** , of new 3995-GG5-002 overlay harness into throttle assembly. Refer to FIG. 6-1.

4. Route and secure as necessary new 3995-GG5-002 overlay harness along existing harness to firewall disconnect located forward of driver's position.
5. Locate and disconnect main chassis harness interconnect, Item **①** , from firewall disconnect. Refer to FIG. 6-1.

- Insert new circuits from new overlay harness into existing main chassis harness interconnect connector Item **1** . Refer to FIG. 5-1. Each wire is tagged with a label depicting which cavity it belongs in. Refer to FIG. 6-1. Note that the wiring/pin out does not change.

- Re-connect main chassis harness interconnect connector, Item **1** , to firewall disconnect. Refer to FIG. 6-1.
- Assure new overlay harness is secured to existing harness as required throughout its entire run. Tape back any extra length as required.
- Using Cummins® INSITE™, verify that no fault codes are generated at key-up. Also verify that appropriate values are seen in regards to throttle pedal position.

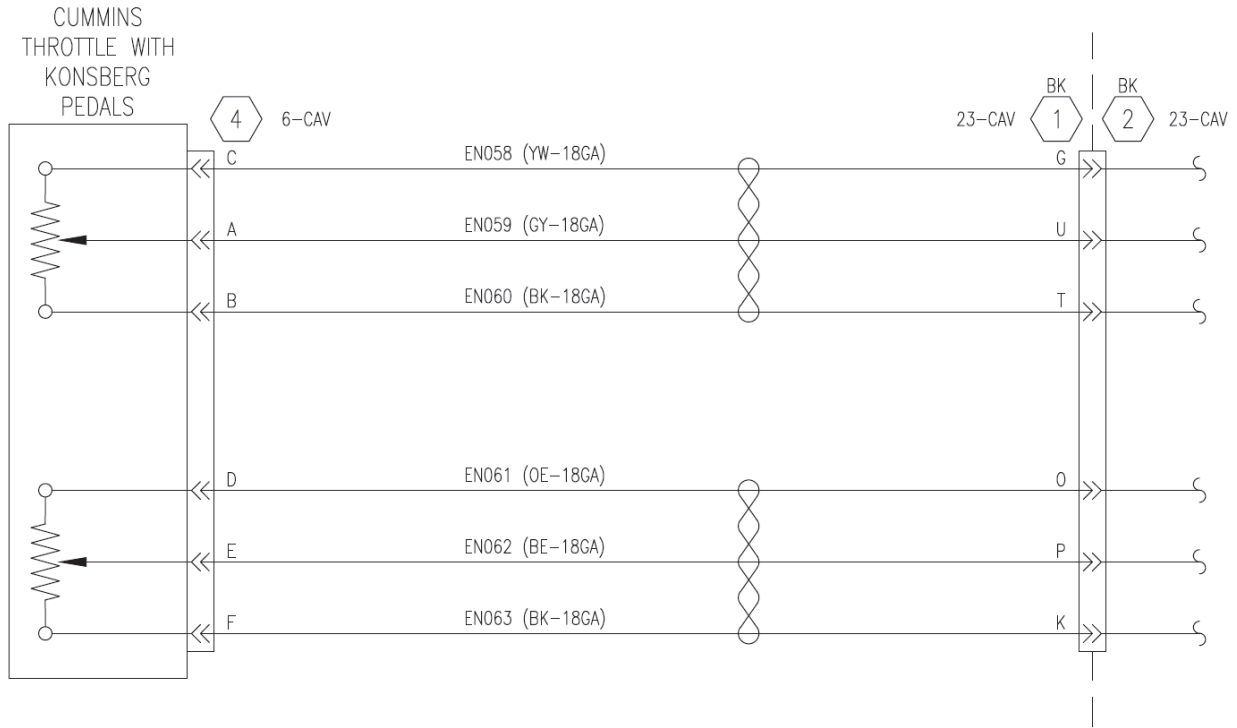
**FIG. 8-1**

1. Identify and disconnect throttle pedal connector, Item ④ in FIG. 8-1, from throttle assembly. Pull back loom 12 inches over wiring terminated into throttle pedal connector. Verify wiring consists of 6 discreet wires (untwisted) then go to step 2. If wiring consists of 2 twisted triplets (refer to FIG. 8-1), replace loom over wiring and reconnect throttle pedal connector, Item ④. No further action is required.

2. Pull back existing throttle pedal connector and stow/tape it back onto existing harness.
3. Connect new throttle pedal connector, Item ④, of new 3995-GG5-002 overlay harness into throttle assembly. Refer to FIG. 8-1.

- Insert new circuits from new overlay harness into existing main chassis harness interconnect connector Item **1** . Refer to FIG. 7-1. Each wire is tagged with a label depicting which cavity it belongs in. Refer to FIG. 8-1. Note that the wiring/pin out does not change.

- Re-connect main chassis harness interconnect connector, Item **1** , to forward electrical compartment disconnect. Refer to FIG. 8-1.
- Assure new overlay harness is secured to existing harness as required throughout its entire run. Tape back any extra length as required.
- Using Cummins® INSITE™, verify that no fault codes are generated at key-up. Also verify that appropriate values are seen in regards to throttle pedal position.
