ATTENTION: This Technical Service Bulletin was issued by Southeast Toyota Distributors, LLC.

SET Advent Navigation System Hard Reset Procedure

02/08/2016- Initial release of SET-TSB-16-001
 02/26/2016- Updated software and radio exchange contact information
Any previously printed versions should be discarded.
 Be sure to review the entire content of this bulletin before proceeding

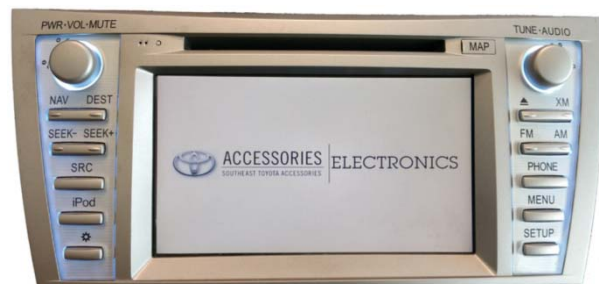
NOTE: The SET Advent Navigation Radios applicable to this bulletin are identified by the "SET Accessories" logo that is displayed during the boot-up process of the navigation. If the screen is not visible, review TIS VIN inquiry for accessory code in vehicle build info indicating port installation or Part Number in service history indicating Dealer installation.

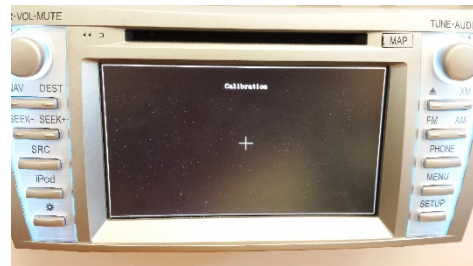
NOTE: Some later software versions may bypass the calibration screen.

8. Touch Calibration Screen is displayed. Follow the calibration prompts by placing your finger in the center of the cross hairs.

NOTE: If the curser moves too rapidly to touch, please refer to Southeast Toyota Parts & Accessory Information document T715 for exchange part ordering process.

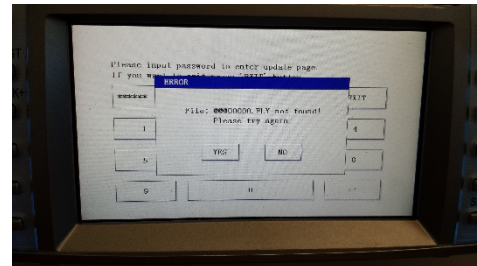
ERROR MESSAGE

- If you get an error message **"@@@00000.FLY Not Found! Please try again"** press the NO button, then press EXIT and confirm by selecting YES.
- The error message indicates new software is required. To request updated software SD card, call VoxxHirschmann Customer Support at 1-866-869-7888
