Service Bulletin

16-095

High Pitched Buzzing/Alternator Feedback from the Speakers

Year	Model	Trim	VIN Range
2017	Ridgeline	RTL Black Edition, RTL Elite	ALL

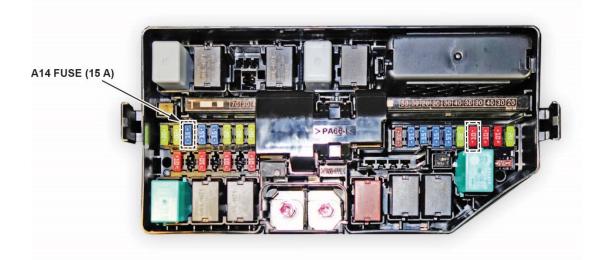
- 1. With the engine running and the audio unit on, remove the A14 (15 A) fuse from the under-hood fuse relay box.
 - If the buzzing is gone, go to REPAIR PROCEDURE.
 - If the buzzing is still present, this bulletin does not apply. Continue with normal troubleshooting.

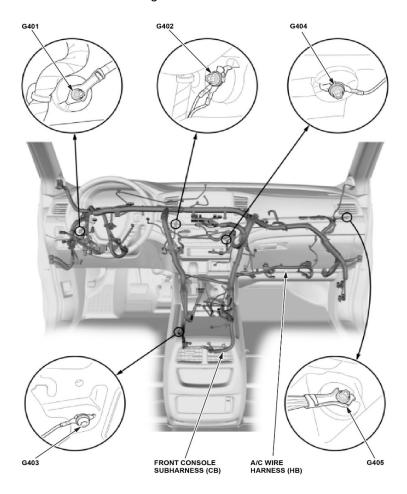
The dashboard wiring harness has insufficient shielding.

8. Remove the dashboard wiring harness.
