GROUP <b>BOD</b>	MODEL <b>2017MY Sorento (UMa)</b>
	NUMBER <b>151</b>	DATE <b>December 2016</b>
<b>TECHNICAL SERVICE BULLETIN</b>		
<b>SUBJECT: SERVICE ACTION: FRONT BUMPER GRILL REPLACEMENT (SA244)</b>

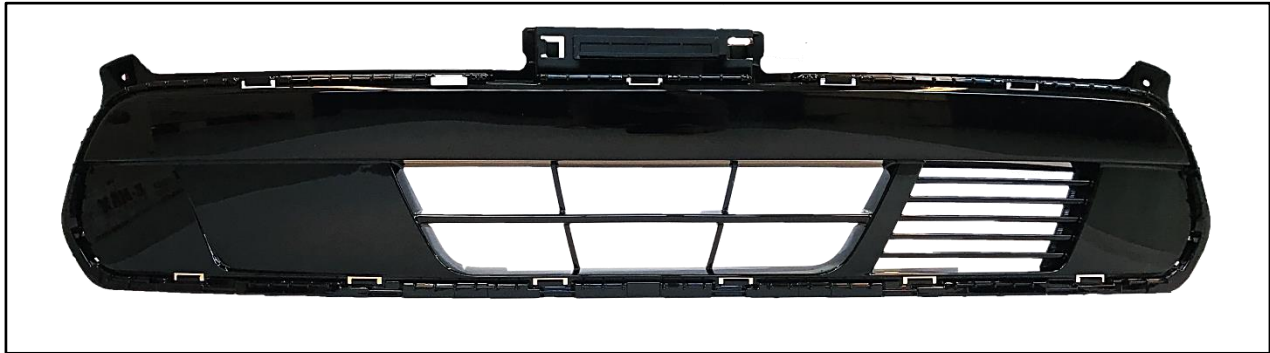
This bulletin provides the procedure to replace the front bumper grill on some 2017MY Sorento (UMa) vehicles, produced from April 18, 2016 to September 2, 2016, which may experience an Autonomous Emergency Braking (AEB) radar blocked message. This is due to the fact that an incorrect air intake grill was installed at the manufacturer. Follow the procedure below to replace the front bumper air intake grill. Before conducting the procedure, verify that the vehicle is included in the list of affected VINs.
