MODEL  
2017MY  
Forte (YDm)

NUMBER  
157

## TECHNICAL SERVICE BULLETIN

**SUBJECT:** SERVICE ACTION: REAR COMBINATION  
LAMP WATER INTRUSION (SA256)

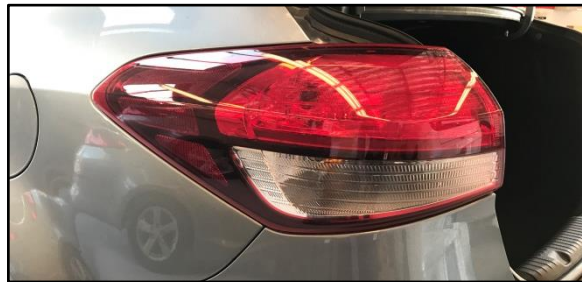
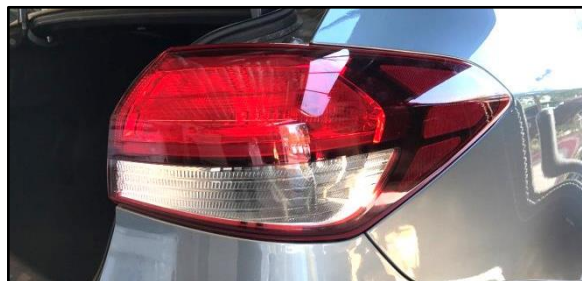
This bulletin provides the procedure to replace the outer rear combination lamp pads on some 2017MY Forte (YDm) vehicles, produced from May 24, 2016 to October 13, 2016, which may exhibit evidence of water intrusion in the outer rear combination lamps. Follow the procedure outlined in this bulletin to replace both left and right outer rear combination lamp pads. Before conducting the procedure, verify that the vehicle is included in the list of affected VINs.
