MODEL
2017MY
Sorento (UMa)

NUMBER
159 (Rev 1, 12/20/16)

TECHNICAL SERVICE BULLETIN

SERVICE ACTION: DRIVER'S WINDOW
RUN CHANNEL REPAIR (SA259)

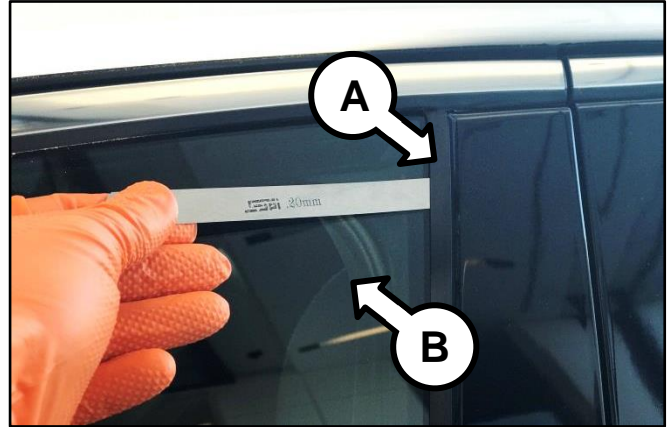
- Using the gap gauge supplied in the kit, inspect the gap between the window run channel (A) and the glass (B) by laying the gauge on the glass and sliding it towards the window run channel with light pressure.

If the gap gauge slides between the glass and window run channel, proceed to the next procedure.
