MODEL
2016MY
Optima (JFa)

NUMBER
161

TECHNICAL SERVICE BULLETIN

SUBJECT: LUGGAGE SIDE TRIM REPLACEMENT

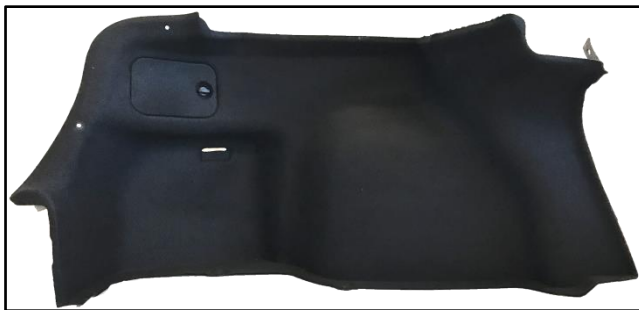
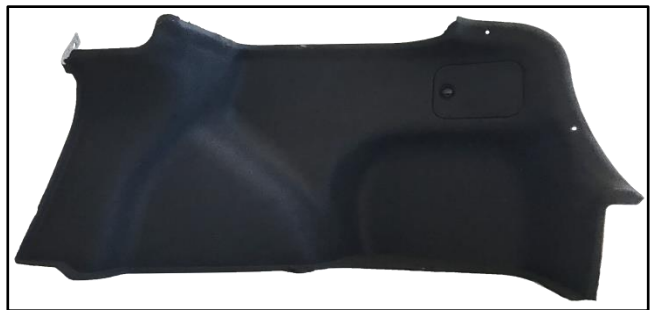
Luggage Side Trim (LH & RH)

This bulletin provides the procedure to replace the luggage side trims on 2016MY Optima (JFa) vehicles, produced from September 28, 2015 to August 16, 2016, which may experience a concern with high cabin pressure. This concern is caused by the isolation pads of the luggage side trim assemblies blocking the extractor vents. Follow the procedure outlined in this bulletin to replace the left and right luggage side trims.

8. Remove and replace the luggage side trims with improved parts.
9. Reinstall all removed components in the reverse order of removal.
