| | GROUP BOD | MODEL 2017MY Sedona (YP) |
| | NUMBER 163 | DATE December 2016 |
| SUBJECT: SERVICE ACTION: FRONT DOOR GLASS RUN CHANNEL INSPECTION (SA263) | | |

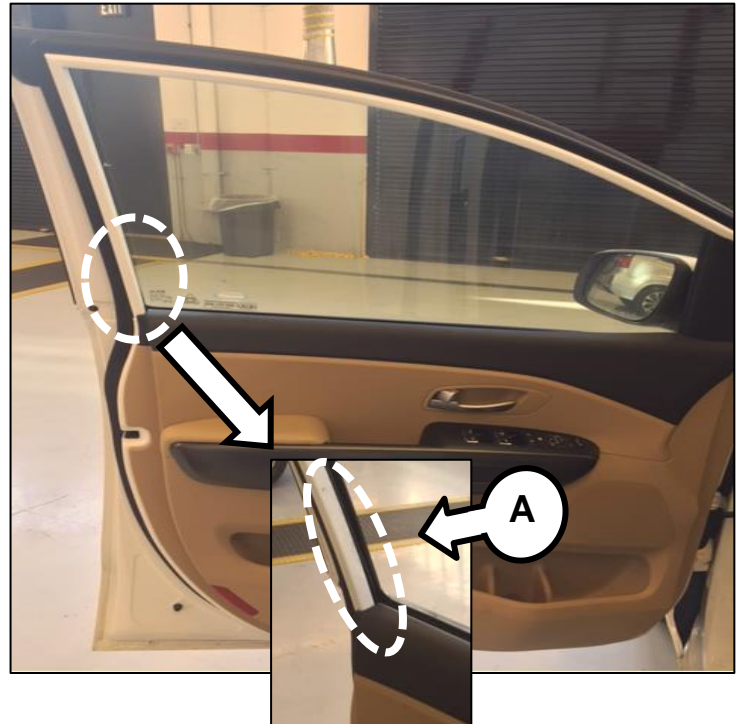
1. With both right and left front windows closed, use a spray bottle to spray water onto the outside lower rear of window / window frame area (A).

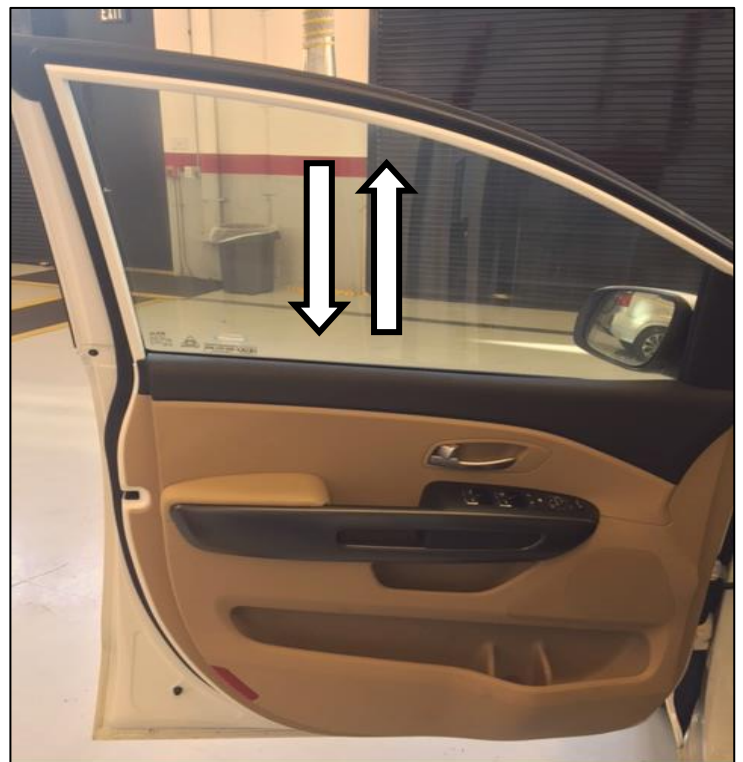
2. Actuate both front windows up and down 5 times. Listen for an unusual noise to occur.

- If an unusual noise is present, proceed to service procedure.
- If no unusual noise is present, no further action is required.

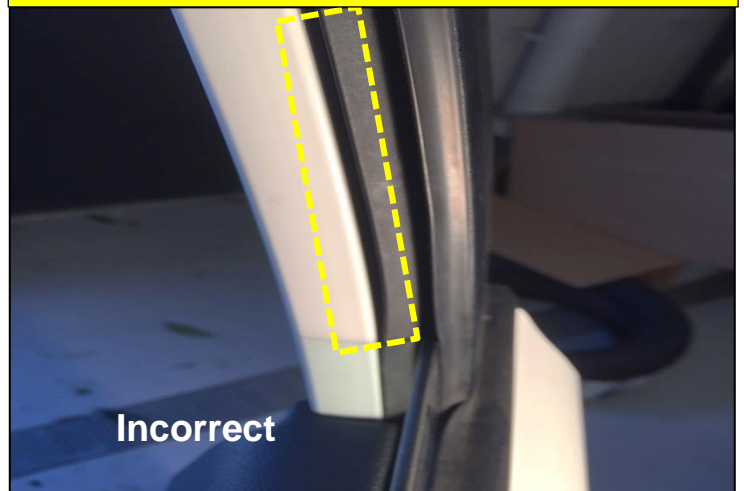
Care must be taken to insure that the run channel is seated properly before installation is complete. If not, the original noise condition will remain.

The inner locking barb is not seated

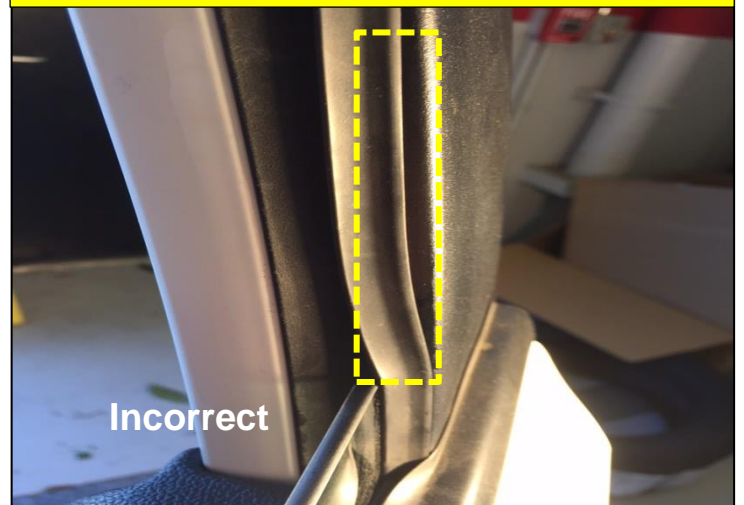
The outer locking barb is not seated

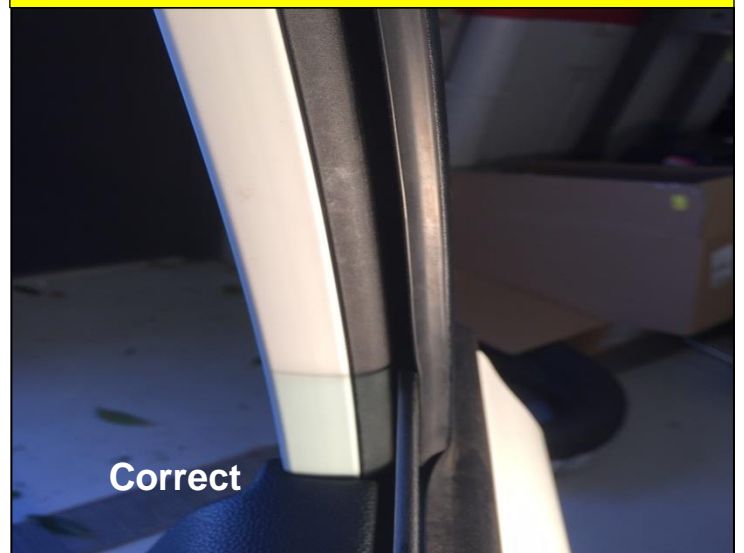
Both locking barbs are correctly seated
