GROUP CHA	MODEL 2016–2017MY Sorento (UMa)
	NUMBER 073	DATE December 2016
TECHNICAL SERVICE BULLETIN		
SUBJECT: COMBINED TSB / SERVICE ACTION: BALL JOINT REPLACEMENT (SA242)

BALL JOINT REPLACEMENT (SA242)

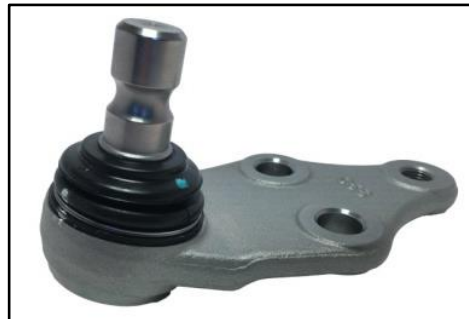
This bulletin provides the procedure to replace both left and right front lower ball joints on some 2016-2017MY Sorento (UMa) vehicles, originally sold in one of twenty-eight (28) salt belt states, produced from November 6, 2014 to December 23, 2015, which may experience an unusual noise from the front of the vehicle, over rough road surfaces. Before conducting the procedure, verify the vehicle is included in the list of affected VINs.
