Service Bulletin

Subject: Air Conditioning Not Getting Cold Enough or Blows Warm Air

Brand:	Model:	Model Year:		Breakpoint		Engine:	Transmission:
		from	to	from	to		
Chevrolet	Sonic	2015	2016	SOP 2015	April 1, 2016	All	All
Chevrolet	Trax (Region of Build, 3: 1st Position of VIN)	2015	2016	SOP 2015	April 1, 2016	All	All

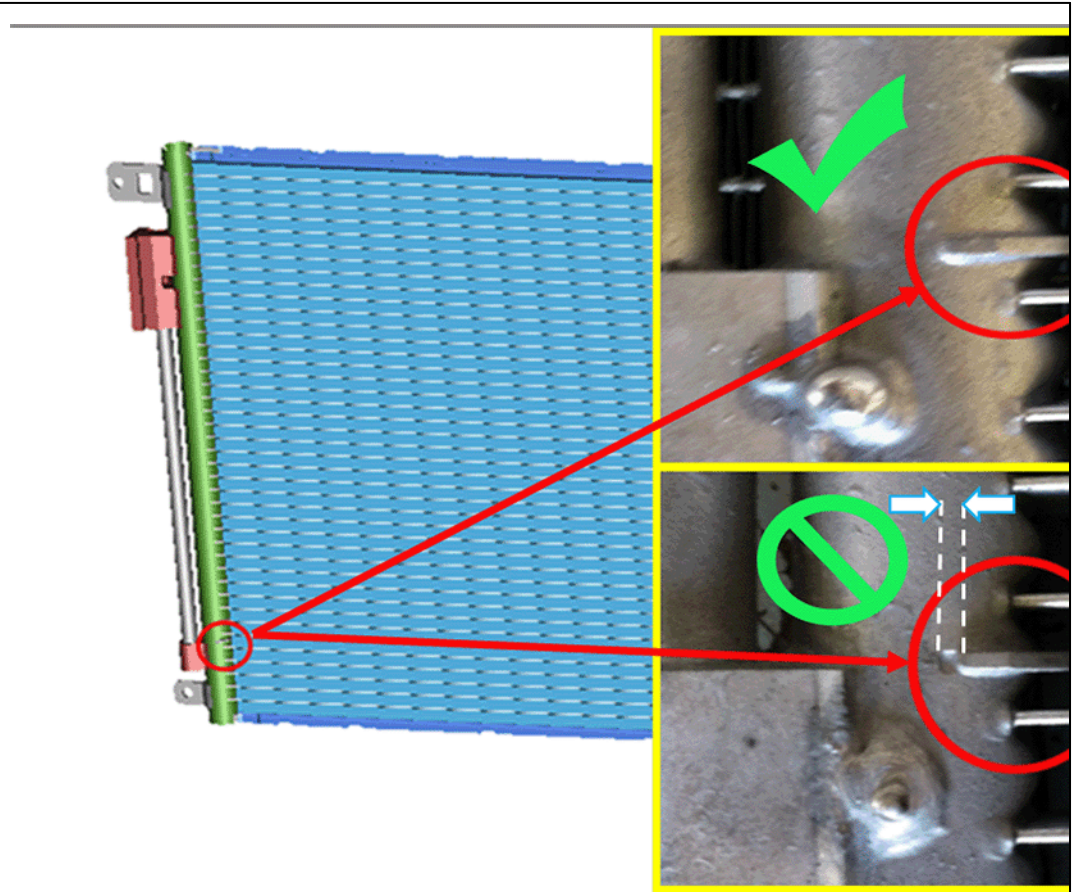
The A/C condenser supplier has found that the cause may be a block off plate that was mis-positioned during their manufacturing process. The plate may not have been fully seated prior to welding, so it may not be directing the flow of refrigerant through an area of the condenser as design intended.

Important: The manufacturing process has been corrected, however, any vehicles produced between the breakpoints shown above may be affected. Because the standard SI diagnostics likely would not pinpoint this cause, the thermal test below is being communicated in this bulletin as a way to verify a good from a mis-built condenser.

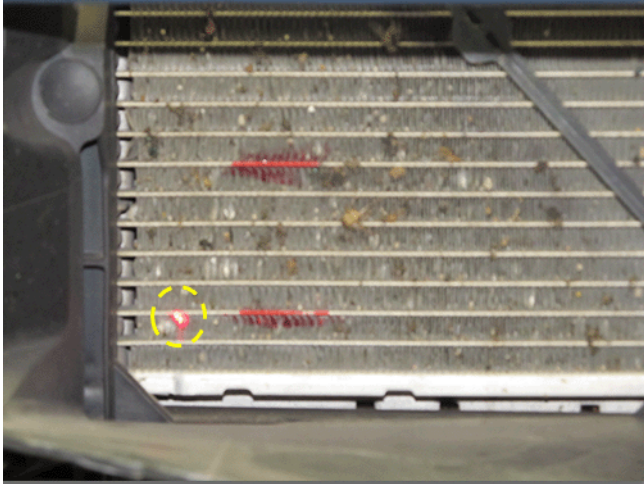
- 4.1. Take a reading at lower tube #2, designated by the lower red line in the graphic above. To obtain a proper reading, the gun beam should be positioned directly on tube #2, about 25 mm (1.0 in) to the right of the manifold.

- If the difference in the reading is at least 10 degrees F or **more**, the condenser is functioning properly and further diagnostics will need to be completed to verify the cause of the condition.
- If the difference in the reading is approximately the same, or within 10 degrees or **less**, the vehicle has a misbuilt condenser. Prior to replacement, confirm that during temperature readings taken, the compressor was running for at least 10 seconds and was still running during measurements. If so, replace the A/C condenser. Refer to the appropriate *Air Conditioning Condenser Replacement* in SI.

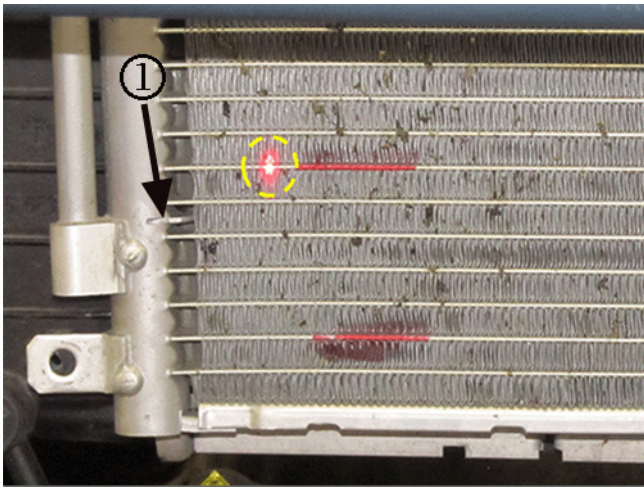
Note: The condenser air baffle has been removed in the graphic above for illustration purposes only. The intent was to show that the #7 tube is 2 tubes above the blocking plate (1).

- 4.2. Next, move the laser dot to the #7 tube (designated by the upper red line). Take a reading ensuring the beam is positioned directly on the tube, approximately the same position from the manifold.
