Service Bulletin

PRELIMINARY INFORMATION

Subject: Road Debris (Mud) on Rocker Panel at Front Door Area

Models: 2010-2015 GMC Terrain

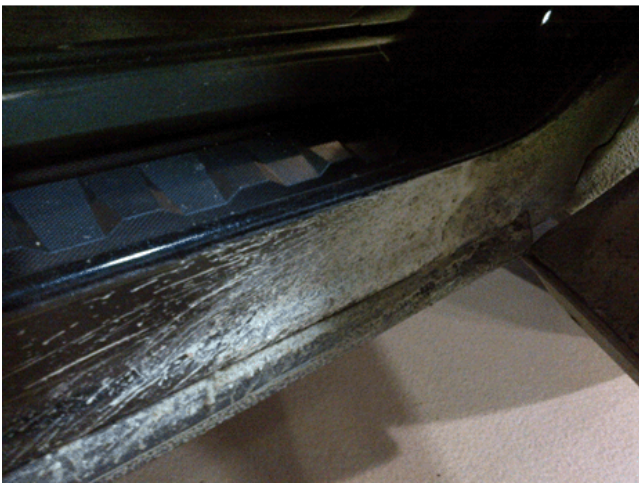
Some customers may comment that road debris (mud) is traveling up between the front doors and the rocker panels.

This condition may be caused by debris working around the front of the door seal.

The installation of GM accessory splash guards will direct the debris away from the door seal and prevent mud from working into the rocker panel area.

Splash guards are available as P/N 19170501 for front splash guards only, or P/N 19170503 for all four splash guards.
